Project 3.16: CT Bridge Girder Sections with Precast Decks and FRP Girder-Deck Shear Connectors

Final Report
April 2024

Principal Investigator: William Davids Ph.D., P.E.
Department of Civil and Environmental Engineering
University of Maine

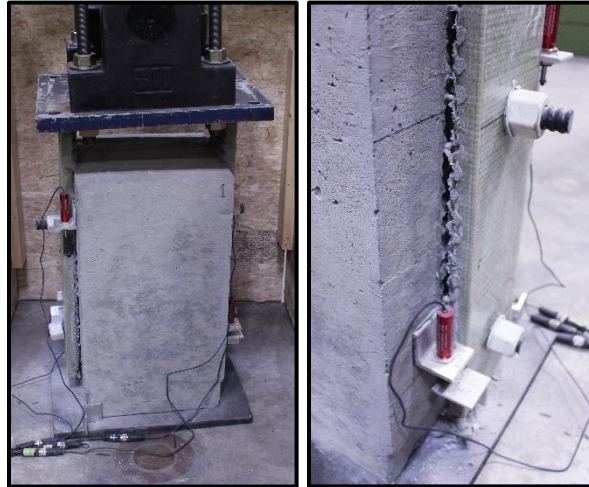
Shear Block 1 completed 368,000 cycles before prematurely failing due to a loss of composite action between the shear-plate and concrete block. This is shown by the visible gap in the connection in Figure 2-6. An inspection of the failed side with the shear-plate removed is shown in Figure 2-7. This inspection revealed that the concrete ridges had sheared off, the top shear connector had splintered apart, and the bottom nut had cracked, further showing the effects of a failure.

Figure 2-6: Shear Block 1 Failure

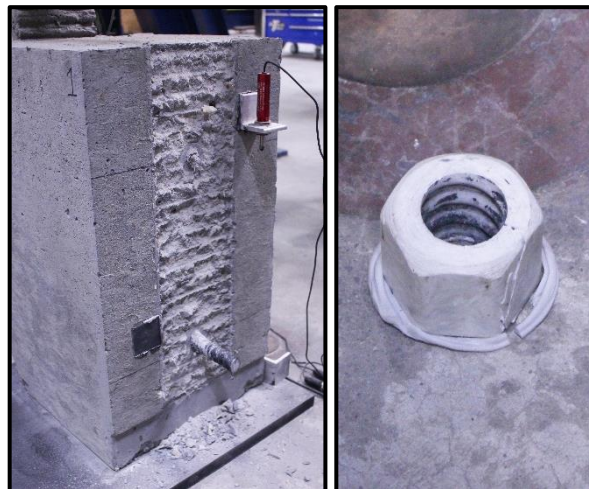
Figure 2-7: Shear Block 1 Failure Inspection

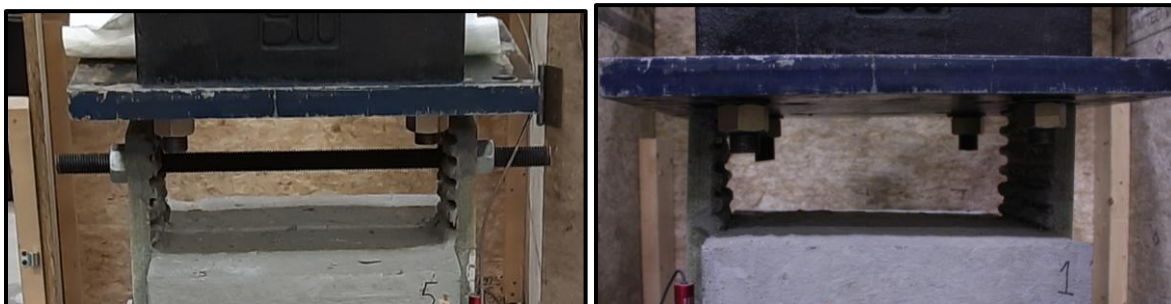
A probable root cause for the premature failure is a missing cross brace between the shear-plates of shear block 1. The cross brace is a steel threaded rod that is intended to prevent unintended eccentric loads from horizontally loading the shear-plates, causing the shear-plates to pry on the other shear connection elements. This prying could fatigue load these components in a way they were not designed for. Figure 2-9 shows a shear block with a cross brace and shear block 1 without its cross brace. Lastly, the low ridge quality of shear block 1, given in Appendix A, may have contributed to the premature failure by further reducing the contact of the ridges.

Figure 2-9: Shear Block with a Cross-Brace (Left); Shear Block 1 Without a Cross-Brace (Right)

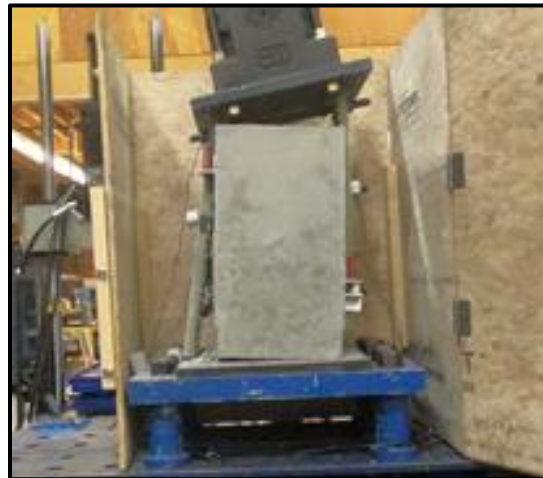
Shear block 3 completed 1.4 million cycles before it prematurely failed, likely due to an unexpected load spike from the actuator. Failure occurred on the side of shear-plate B as shown in Figure 2-12. Figure 2-13 shows shear-plate B’s failed shear connectors, concrete ridges, and a bend in shear-plate A. Unlike in other failures, the bottom FRP nut also was found on the ground apart from the shear block.

Figure 2-12: Shear Block 3 Premature Failure

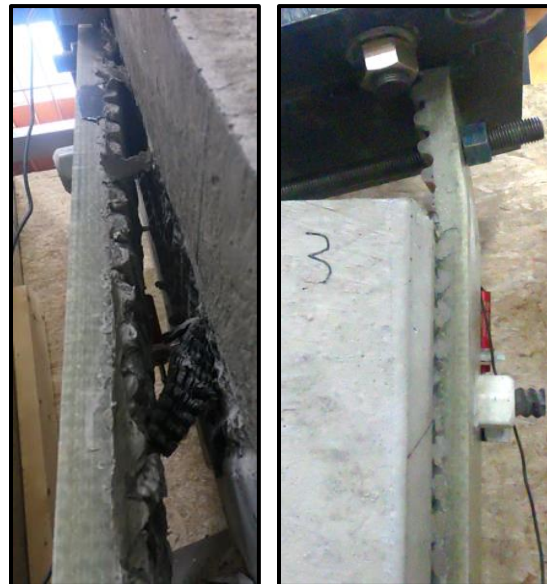
Figure 2-13: Failed Side (Left); Cracked Nut (Center); Bent Shear-Plate A (Right)

Shear block 3 likely failed due to a load spike caused by a malfunction of the Instron controller. Despite the premature failure however, it is possible that the shear block would have failed prematurely during fatigue testing. Both the accumulated slip and stiffness of shear block 3 exceeded those of the specimens that completed 6 million fatigue cycles. Figure 2-114 shows the accumulated slip in shear-plate B near failure reached 0.015 in., three time that of shear block 2. Additionally, the stiffness of shear block 3 was already half that of shear blocks 2 and 4 at one million fatigue cycles as shown in Figure 2-5. Notably, a bend occurred in shear-plate A, which is unique to this shear block. This may be a result of combined bending and buckling in the plate. As plate B failed, the cross braced was pulled with it, applying a lateral bending force on plate A. Additionally, as the plate bent it was compressed as well, increasing the moment, and potentially buckling the plate as well.

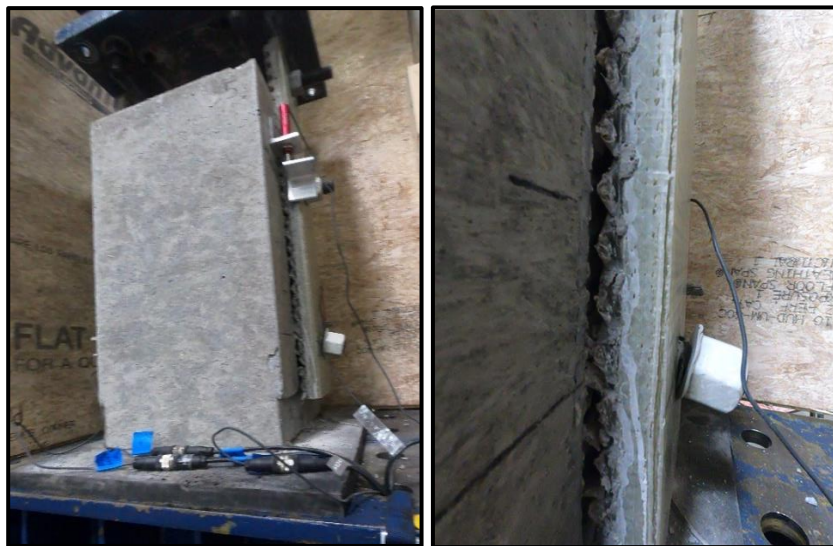
Shear block 5 completed 4.5 million cycles before the side of plate B unexpectedly failed as shown in Figure 2-17. Like shear blocks 1 and 3, the concrete ridges, bottom FRP nut, and Gbar shear connector had failed. Figure 2-18 shows the accumulated slips between the shear-plate and concrete block of the shear block over the test duration. These accumulated slips remained relatively constant for the first three million load cycles. After this, the slip in plate B began to increase rapidly, failing with 0.1 in. of accumulated slip. Figure 2-19 shows the average slip-load response of the shear block at 1,000 cycles and at 4.5 million complete cycles. Since the horizontal displacement between the curves is the difference in accumulated slip between the two cycles, the X-axis scale is relatively large for showing the slips within each load cycle. Additionally, the distance between these two curves is about 0.055 in. and not 0.1 in. since these curves average the slips of both sides of the shear block together.

Figure 2-17: Failed Shear Block 5

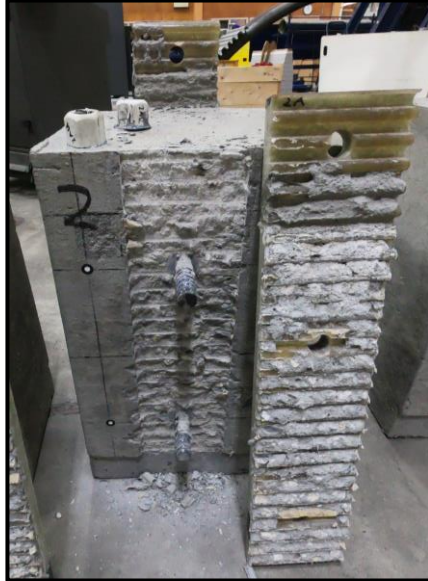
During the failure of shear block 2, there was a large and a small load peak, followed by a plateau preceding failure in Figure 2-2. To determine the corresponding failure sequence of the shear connection, the photos presented in Figures 2-26 and 2-27 were taken. Figure 2-26 shows the shear block post failure. Plate A was removed to examine the extent of the damage, revealing the concrete ridges had sheared off the specimen, and both FRP nuts had cracked. The G_{bar} however, had not failed in shear. Meanwhile, Figure 2-27 shows crack propagation through the bottom FRP nut as it split apart. These images correspond to the transition between the plateau in Figure 2-22, and the rapid load drop afterwards. From these images it is most likely that failure started with the concrete ridges at peak load. Then, the shear connectors began to bend as they carried more of the shear load. This caused the shear-plates to push against the FRP nuts, which then cracked under the loading. This allowed the shear-plate to then slide along the shear connector, unloading it.

Figure 2-26: Shear Block 2 Failure

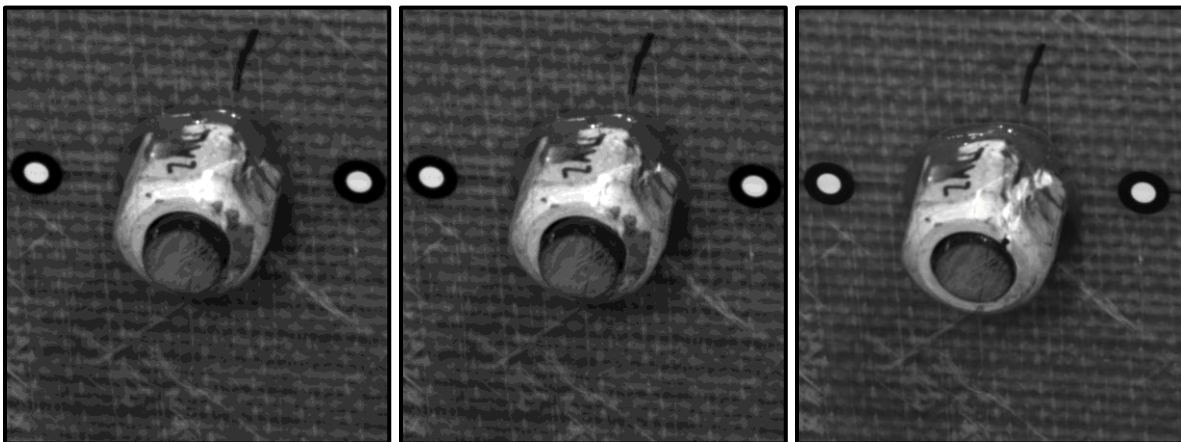
Figure 2-27: Shear Block 2 DIC Progressive Nut Failure

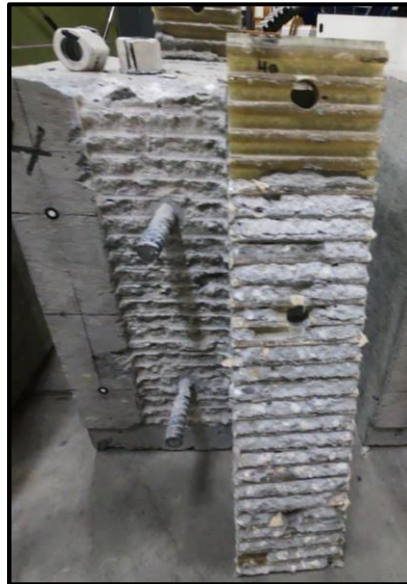
The effects of failure on shear block 4 are like those observed in shear block 2. Figure 2-30 shows the concrete ridges failed, and the G-bar shear connectors did not. The FRP nuts are cracked as well. Figure 2-3 shows the DIC frames corresponding to before and after the first load-displacement peak seen in Figure 2-2. In Figure 2-31 a crack forms in the concrete to the right of the shear-plate along its bottom edge, and a crack to the left expands, spalling concrete off. Figure 2-32 shows the DIC frames corresponding to the second load-displacement peak. In these frames the previous cracks expand and release from the stud, and the FRP nuts crack apart.

Figure 2-30: Shear Block 4 Inspection

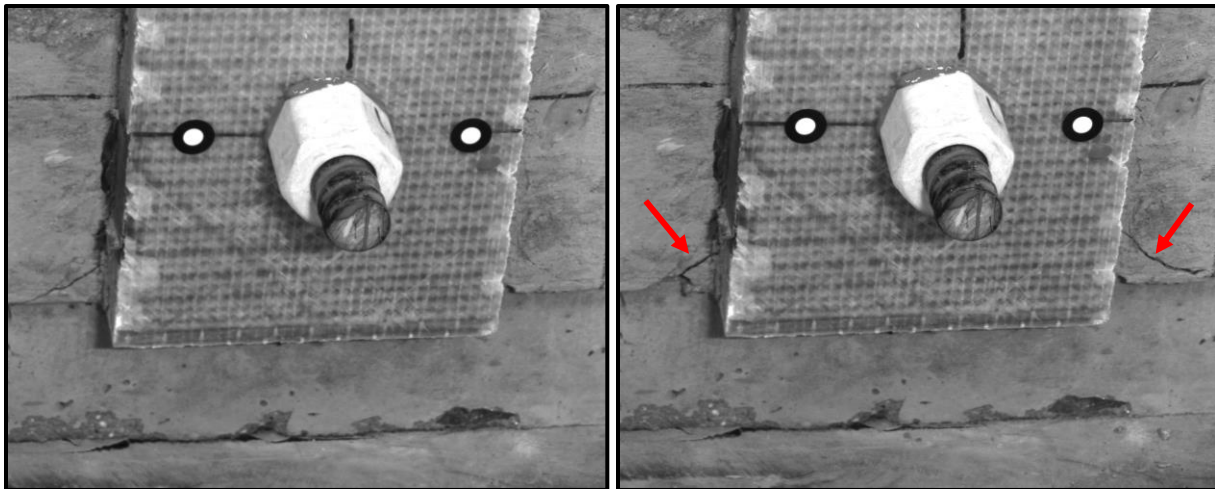
Both sets of DIC frame suggest the concrete ridges initially failed or started failing during the first load peak, leaving the shear connectors to carry the load until the FRP nuts failed during the second and final load peak.

Figure 2-31: Shear Block 4 DIC Frames Before and After the First Load-Displacement Peak

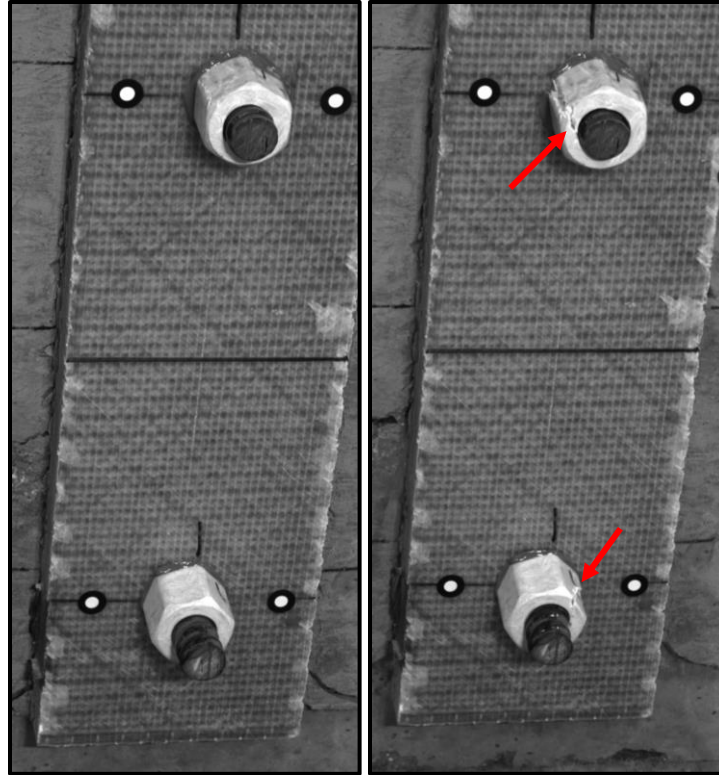
Figure 2-32: Shear Block 4 DIC Frames Before and After the Second Load-Displacement Peak

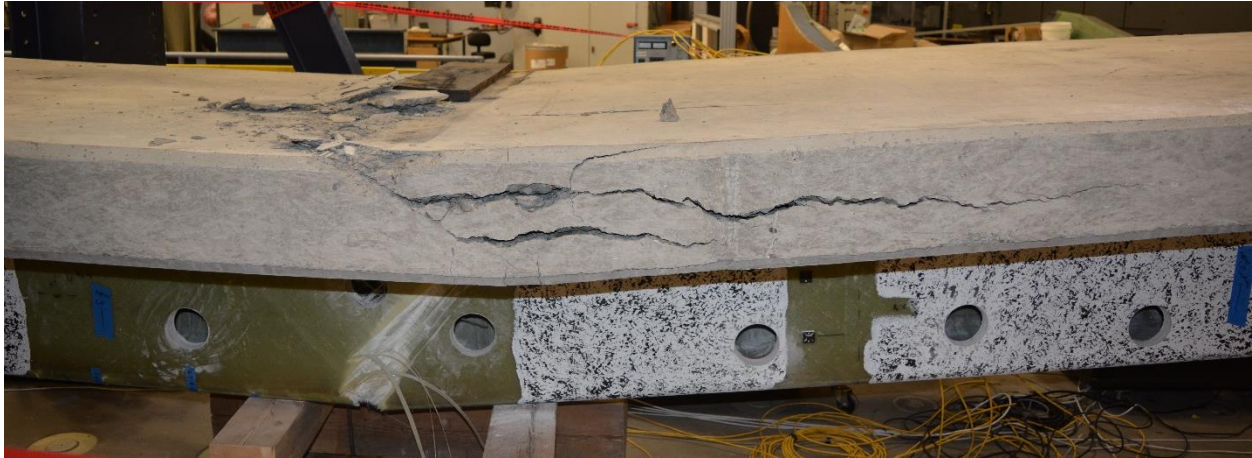
Figure 4-13: Image UTC-4 of Failure Location and Damage
