Vision-Based Detection of Bridge Damage Captured by Unmanned Aerial Vehicles

Final Report
September 2025

Principal Investigator: Paolo Stegagno

Electrical Computer and Biomedical Engineering
University of Rhode Island

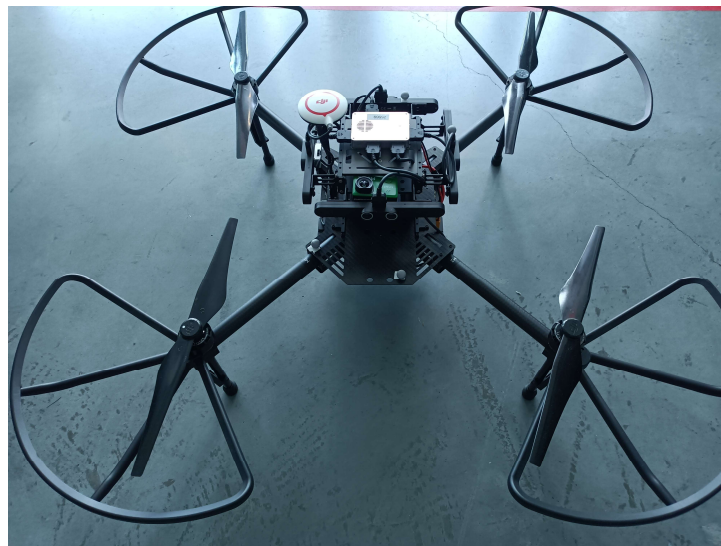
Drone Configuration: Completed by May 2024, enabling stable flight and image capture under bridges. The selected drone was a DJI Matrice 400 with DJI Guidance system [13]. The Guidance System was necessary to replace unreliable GPS signals using cameras and sonar. A MapIR Survey3 camera was installed on the top of the drone to collect the needed images. A picture of the drone setup is shown in Figure 1.

Figure 1: Drone setup with the guidance system and the camera.

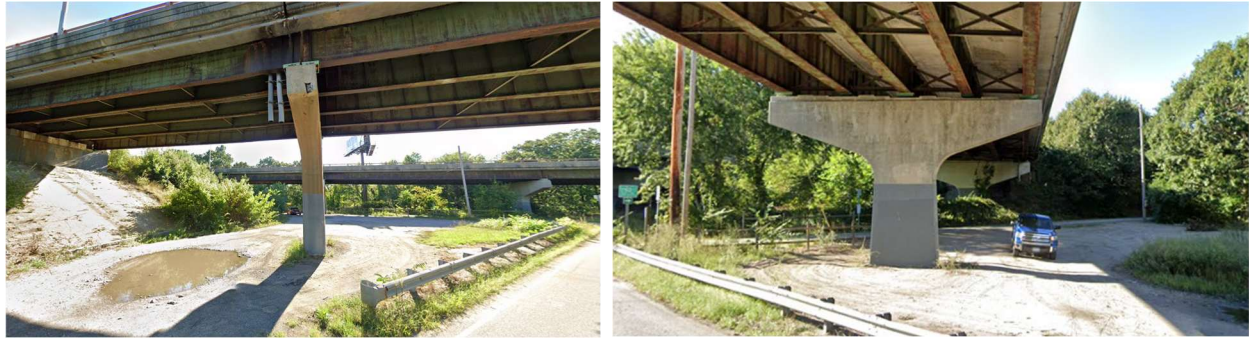
Bridge Selection: The bridges selected for the study are Bridges Nos. 072551 and 072571, located on I-295 over West Natick Road and the Washington Secondary Trail. Both bridges are easily accessible and have four spans, of which only two above traffic. Therefore, imagery of the concrete ceiling of six spans were collected and used in the study. Two images of the selected bridge are provided in Figure 2.

Figure 2: Two images of the bridges selected for this study.

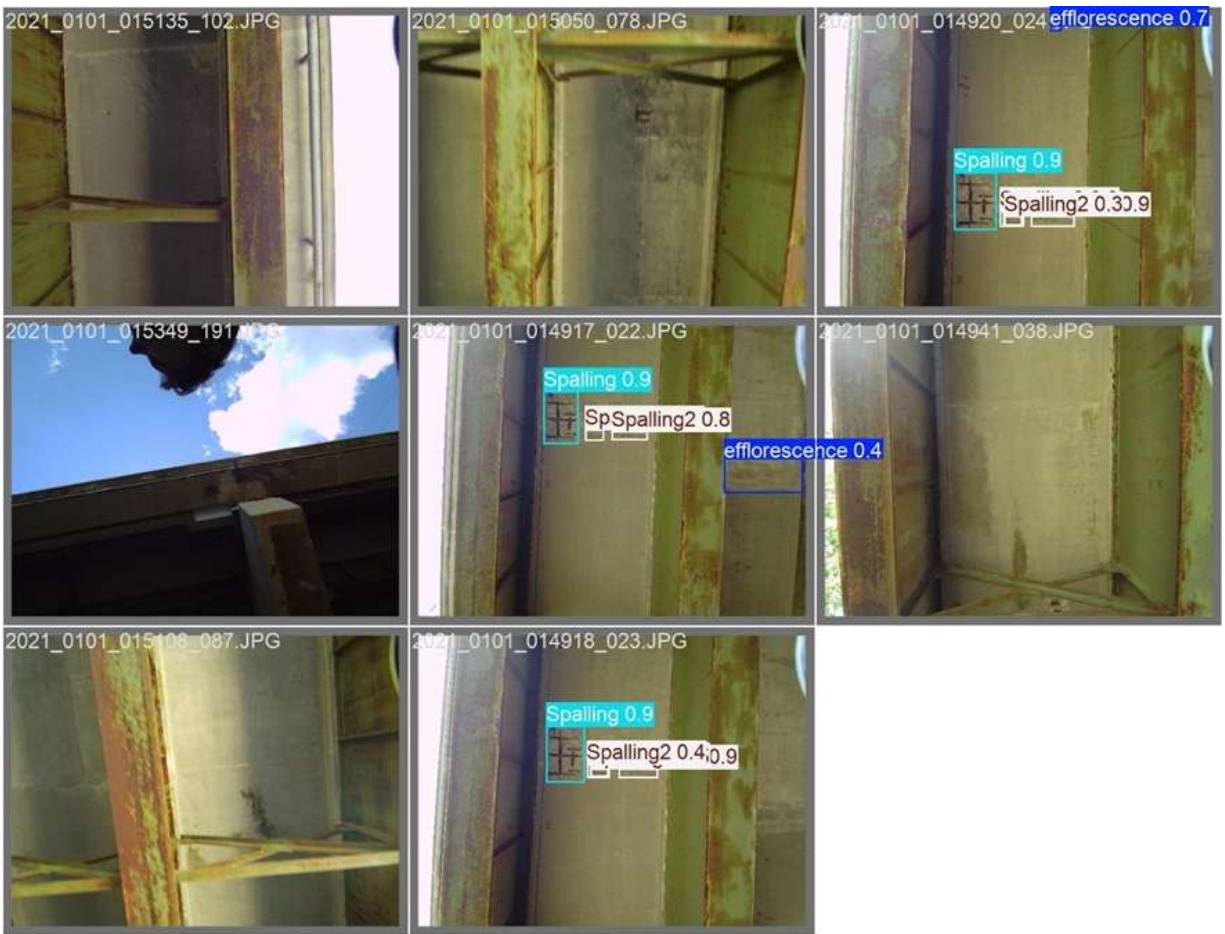
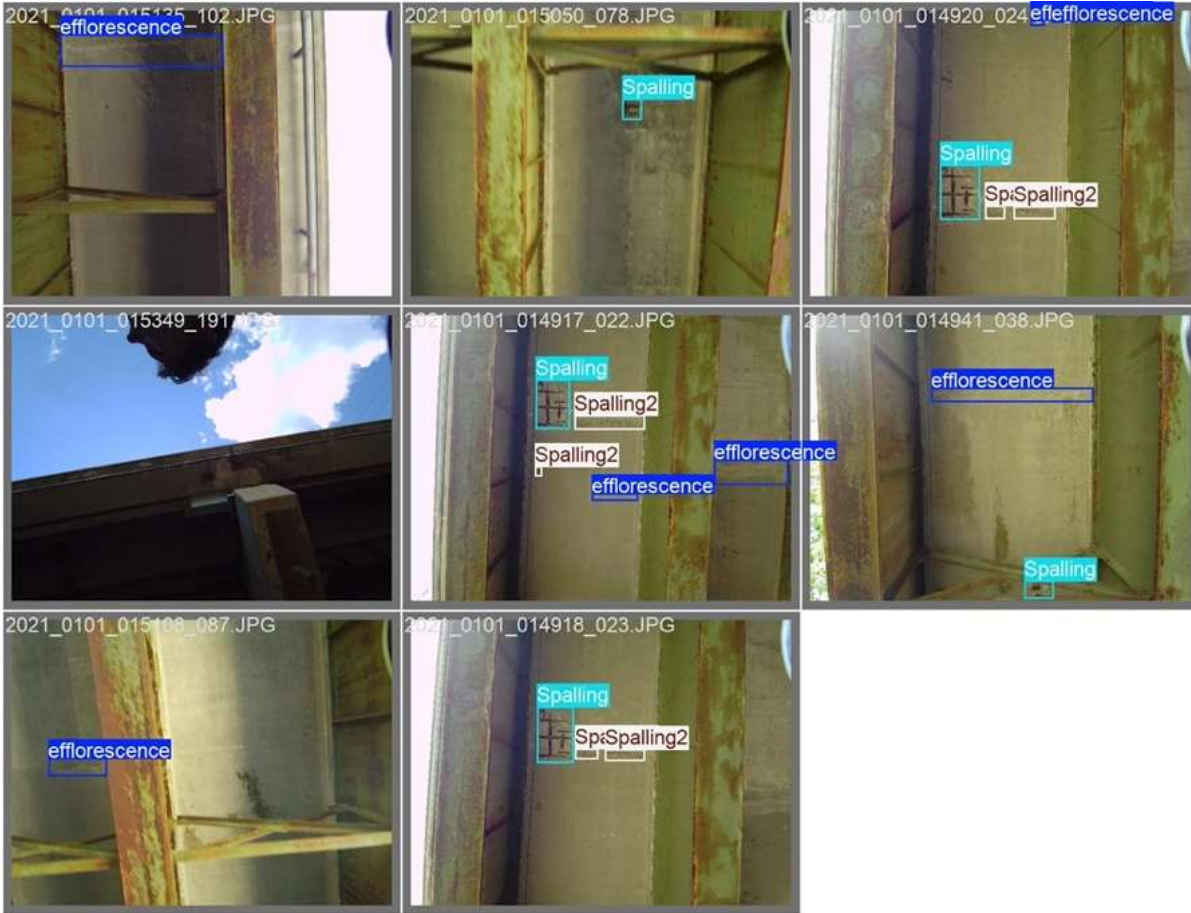
Visualizations of validation samples show accurate detections for most defects, with bounding boxes aligning well with ground truth. For example, in *Figure 4 Illustration of YOLO-v8 visualization samples: (a) validation_batch_labels vs. (b) validation_batch_pred*, spalling and cracking are detected with high confidence, while smaller or less distinct defects like efflorescence are occasionally missed.

Fig 4. Illustration of YOLO-v8 visualization samples: (a) validation_batch_labels; and (b) validation_batch_labels
