Quarterly Progress Report

Project Number and Title: 1.4 Electromagnetic Detection and Identification of Concrete Cracking in Highway Bridges

PI: Tzuyang Yu (UMass Lowell)

Reporting Period: 07/01/2020~09/30/2020

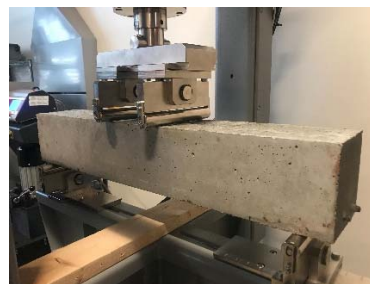
Fig. 1 b) Picture of 4- point bending

A four-point bending test was carried out to generate flexural cracks on a 36''x 6''x6'' reinforced concrete (RC) beam specimen as shown in Fig. 1. **Fig.1a)** and **Fig. 1b)** show our experimental set up. **Fig. 1c)** shows few flexural cracks observed on the surface of concrete. SAR images were collected on the same RC beam inside an anechoic

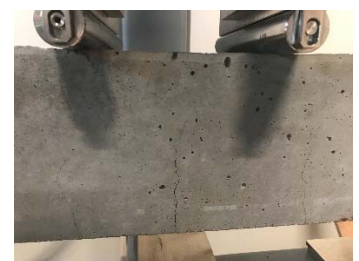
Fig. 1 c) Cracks generated

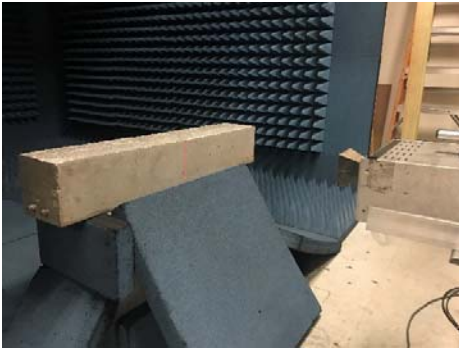
Fig. 2a) Laboratory SAR imaging

chamber, before and after cracking. Experimental setup and the SAR images collected at the range of 45-cm in range-cross-range domain are shown in Fig. 2a), Fig. 2b), and Fig. 2c), respectively.

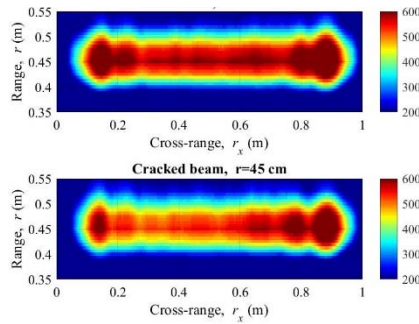
Fig. 2b) SAR image of Intact and cracked beam

From Fig. 2b), it was observed that there is an overall amplitude reduction in the SAR image of cracked RC beam when compared to the SAR image of intact RC beam. This can be attributed to loss in moisture since the SAR image of cracked RC beam was collected six hours after the SAR image of intact RC beam was collected. Assuming that the moisture loss in concrete is uniform throughout the RC beam, compensation of moisture change was applied to the SAR image of cracked RC beam and shown in Fig. 3a) with contours at an SAR amplitude of 540. Fig. 3b) compares two SAR curves of intact and cracked RC beams, and Fig. 3c) compares the SAR contours intact and cracked RC beams.

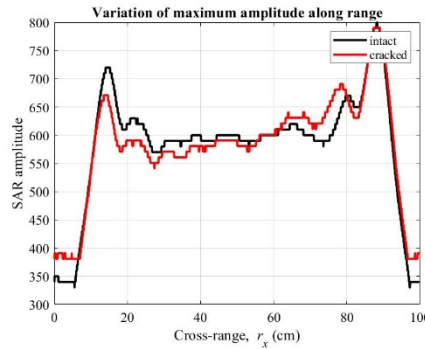
Fig. 3b) Variation of max SAR amplitude along cross-range after moisture compensation
