Development & Experimental Assessment of a Live-load Moment Continuity

Final Report June 2025

Principal Investigator: William G Davids, PhD, PE

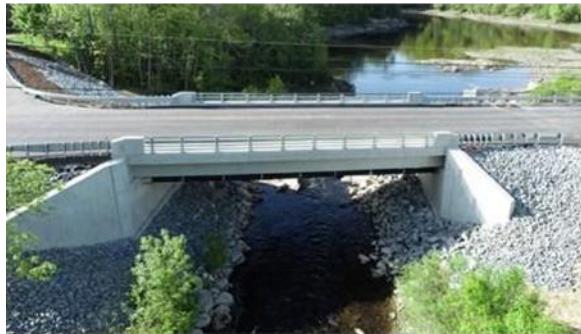
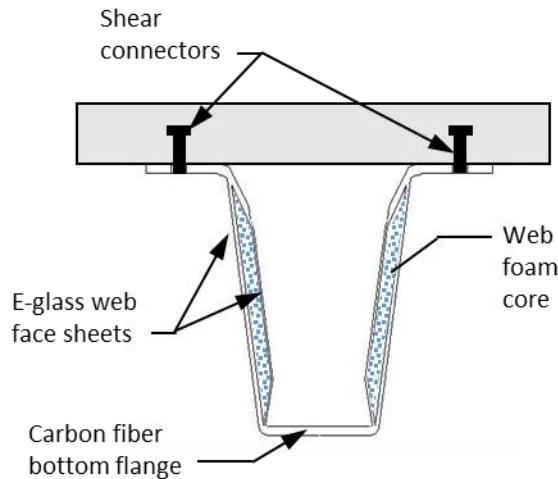
Figure 1: In-Service CT girder bridge and typical CT girder cross-section

al. 2017; Siwowski and Rajchel 2019). In the United States, four FRP composite tub (CT) girder bridges have been built since 2021 (Pinkham et al. 2024; Davids et al. 2022a), indicating growing acceptance of this technology. For reference, Figure 1 shows an image of an in-service CT girder bridge and elements of a typical CT girder cross-section composed of foam-core webs with ± 45 degree E-glass face sheets, shear connectors between the concrete deck and girder, and a largely unidirectional carbon fiber bottom flange.

a) Hampden, Maine CT girder bridge

b) Elements of a CT girder cross-section

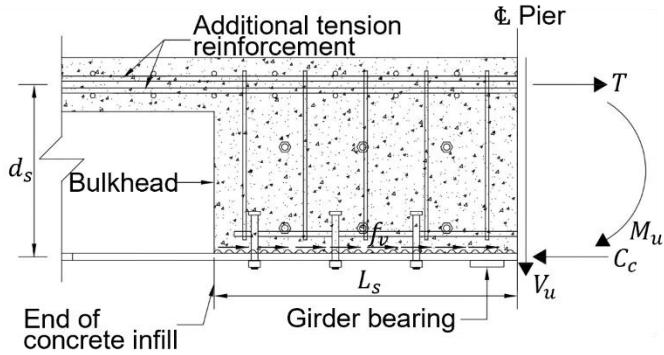
Figure 2: Continuity joint elevation and definitions

The proposed continuity joint is shown schematically in Figure 2. It relies on concrete infill within the girder section for a length L_s that is cast with the deck concrete and confined with an internal, non-structural bulkhead. Since the open girder section acts as a concrete form and typical CT girder construction requires a full-width diaphragm at supports, additional field-installed formwork is minimal, making it simple to fabricate. Beyond the end of the splice at the bulkhead, the girder, deck and deck reinforcing carry the full moment and shear within the span.

However, at the pier centerline, abutting girders are discontinuous, and moment due to superimposed live and dead load is carried by a reinforced concrete section that results in the usual stress resultants C_c from concrete in compression and T provided by additional deck reinforcement in tension (see Figure 2). The key to success of the splice is the transfer of bending compression stress in the girder bottom flange, which is largest at the bulkhead, to the concrete infill. This is accomplished through interface shear stresses f_v between the interior of the girder and the concrete infill (see Figure 2) that are developed via shear friction.

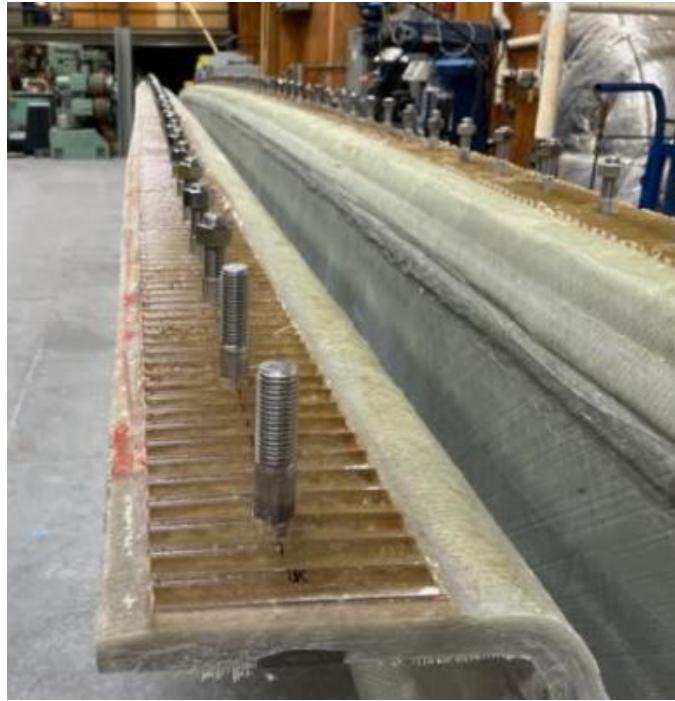
Figure 3: CT girder top flange ridges and stainless-steel shear studs

As illustrated in Figure 3, CT girders rely on 6.4 mm amplitude sinusoidal ridges infused to the top flanges and stainless steel or galvanized fasteners embedded in the deck to ensure composite action between the deck and girder through mechanical interlock. Prior compression-shear experiments have shown that an average interface shear stress at failure of $f_v = 4.12$ MPa can be reliably achieved using typical bridge deck concrete mixes and 25.4 mm diameter A325 or stainless steel studs spaced at 305 mm on center on a 152 mm wide by 559 mm long flange plates (Davids et al. 2022b). A recent full-scale strength test of a CT girder subjected to four-point bending with A325 shear studs spaced at 305 mm on center verified a similar level of shear stress transfer from the deck to the FRP girder flange prior to CT girder flexural failure (Davids et al. 2024). This implies that if the same ridges can be infused on the inside of the girder over the length L_s with shear studs passing through the shear plane with a similar interface tributary area to that used in prior testing, a value of $f_v = 4.12$ MPa can be achieved within the continuity joint.

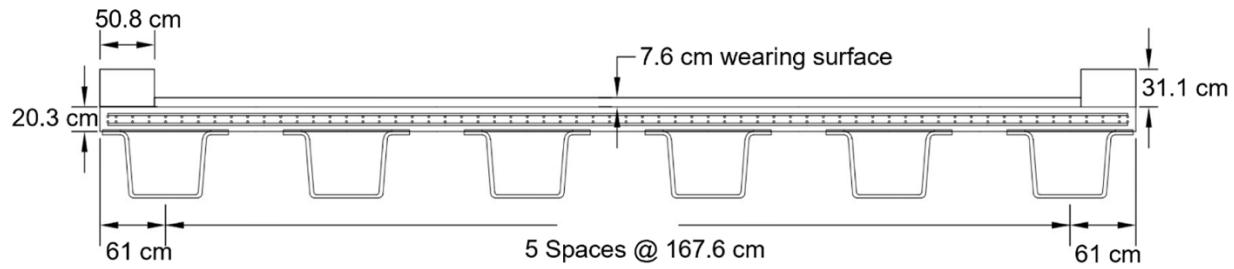
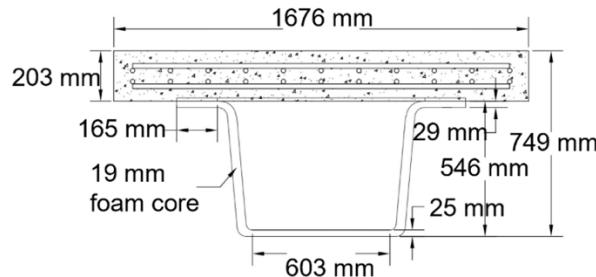
Figure 4: Details of model structure and CT girder cross-section

The cross-section of the model structure used for the continuity joint specimen design is illustrated in Figure 4a and details of an individual girder cross-section are shown in Figure 4b. The model structure deck width and girder spacing are identical to those of an 11.58 m simple span CT girder bridge constructed in Westerly, Rhode Island in 2022, and the Westerly live load moment and shear distribution factors of 0.69 lanes of live load per girder were used to size a typical interior girder. However, the model structure is a continuous bridge with two, 15.24 m spans, and the girder has a wider bottom flange to provide a larger width b_s over which shear transfer occurs. Roller supports are assumed at each abutment, which will maximize negative moment at the interior pier live load continuity joint. These dimensions correspond to an overall span-to-depth ratio of 20.3, which is 22.4% greater than that of the simple span Westerly, RI structure. The girder dimensions also correspond to an approximately 2/3 scale version of the girders in the two-span bridge currently under construction in Old Town, Maine, which will be deeper but have the same bottom flange width. The maximum Strength I interior girder negative moment and shear at the pier centerline were calculated using the provisions of AASHTO (2024) and the MaineDOT (2018) to be $M_u = 1447$ kN-m and $V_u = 447$ kN, respectively. We note here that the MaineDOT requires bridges to be designed for Strength I assuming a truck that is 25% greater than the AASHTO-specified HL-93 vehicle.

The CT girder section shown in Figure 4b features foam-core webs with ± 45 degree E-glass web face sheets for shear strength that are integrated into the top and bottom flange layup and unidirectional carbon fiber in the bottom flange for bending strength and stiffness. The bottom flange thickness and number of bottom flange carbon plies were constant along the span. The girder was fabricated using vinyl-ester resin and vacuum-infusion. The concrete deck had a nominal compressive strength of 28 MPa and conformed with a typical MaineDOT Class I mix used for bridge deck construction. The 28-day compressive strength was 43 MPa based on three cylinder tests, and the compressive strength was 51 MPa based on three cylinder tests at the time the specimen was loaded to failure (103 days after casting). The webs were designed for both shear strength and shear buckling based on the procedure described by Schanck et al. (2023).

(a) Model structure cross section

(b) Specimen cross section

The two-span continuous bridge with the section properties listed in Table 1 and girder dimensions given in Figure 4b is predicted to deflect 1.44 cm due to live load, meeting the requirement of $span/1000 = 1.52$ cm for a vehicular bridge that also carries pedestrians (AASHTO 2024). However, the simple span bridge with the same cross-section exhibits a maximum mid-span live load deflection of 3.89 cm, which significantly exceeds the 1.52 cm maximum. To ensure that the simple span bridge satisfies the deflection requirement, two options were considered. For Option 1, the depth of the FRP section was increased while maintaining the compression flange thickness of 25 mm and the other properties given in Table 1. For Option 2, the depth of the FRP cross-section was increased, and the thickness of the compression flange was also increased up to a maximum of 51 mm. The additional compression flange thickness is obtained by adding unidirectional carbon fiber layers to maximize E_1 and thus the section bending rigidity. Practice has shown that flange thicknesses greater than 51 mm can be challenging to successfully infuse, and were not considered practical.

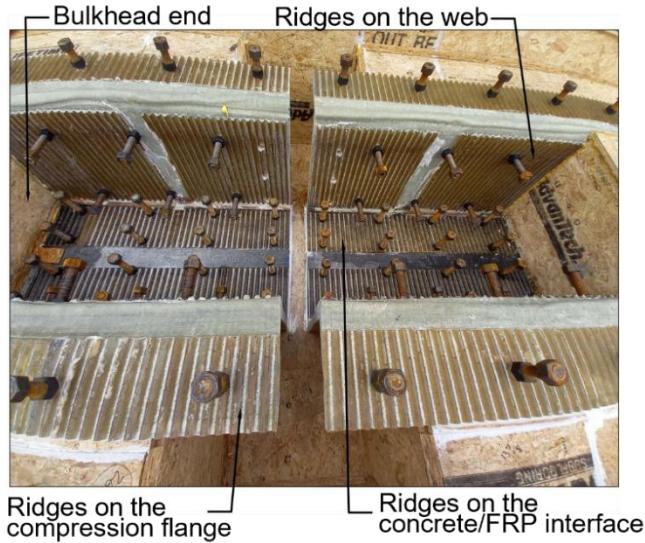
Figure 5: Girder interior photo

Error! Reference source not found.5 shows a photo of the ends of the two, 3.35 m long girder sections used to make the jointed specimen with ridges infused on the interior and top flanges. During specimen fabrication, a 75 mm wide center section of the interior of the bottom flange was created without ridges to promote infusion. This reduced b_s from the assumed value of 532 mm to 457 mm, which is accounted for in subsequent analyses of the test results. Further, to promote continuity between the full depth of the FRP section and concrete infill, vertical ridges were also infused on the interior surface of the webs over a height of 457 mm as shown in Figure 5. The girder was fabricated as a single member and then cut in half to make it discontinuous prior to casting the deck, continuity joint, and diaphragms with a single pour. As shown in Figures 5 and 6, the bottom flange had 12, 25 mm diameter A325 bolts anchoring the concrete to the bottom flange, which corresponds to a bottom flange ridge area tributary to each fastener of 435 cm². This is 2.3% more than the 425 cm² tributary to each fastener in the compression-shear tests of Davids et al. (2022b). Each section of the specimen was originally drilled to accommodate 16 bolts through the bottom flange as shown below, but external nuts were not installed on the row of four fasteners closest to each end of each section to better replicate a field

scenario where each girder end rests on an individual bearing. Six fasteners were used to anchor each web over half the splice length.

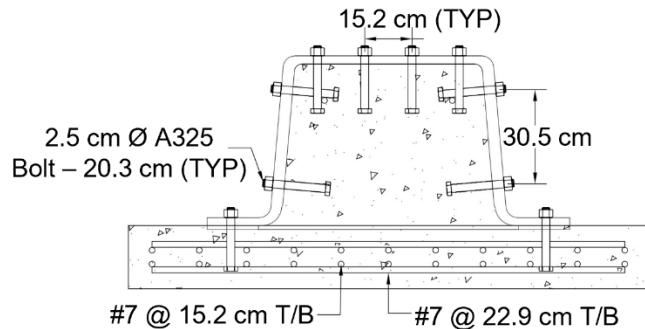
Figure 6: Test girder cross-section

As shown in Figure 6, the test configuration oriented the specimen with the deck on the bottom, which allowed the application of a negative moment in the actual girder orientation using a compressive load from a hydraulic actuator (more details of load application are provided in the next section). Each one of the two CT girder sections terminated at approximately 38 mm from the specimen mid-span to mimic a normal construction detail and ensure there was no direct bearing between the two girder bottom flanges (refer to Figure 5). A full-width, 45.7 cm thick diaphragm was cast at mid-span and 61 cm diaphragms cast at the girder ends over the full depth of the specimen, which is typical for CT girder bridge construction. The longitudinal deck reinforcing consisted of 22-#7 bars with a specified yield strength of 414 MPa, which provided a moment capacity $\bar{\Omega}M_n$ at pier centerline of 1641 kN-m, 13.4% greater than the Strength I moment of 1447 kN-m. While slightly less tensile reinforcing could have been used, the excess flexural capacity was purposeful to allow larger stresses f_v to be applied to the girder-concrete interface prior to failure. Two #6 bars were included in the infill region near the carbon fiber compression flange to promote handling of the girder, as all concrete was cast with the deck on top before the specimen was flipped for testing as oriented in Figures 6 and 7. Code-minimum stirrups were also included within the splice, and according to AASHTO (2024) the reinforced

concrete section had sufficient shear strength to carry the full Strength I factored shear force $V_u = 447$ kN.

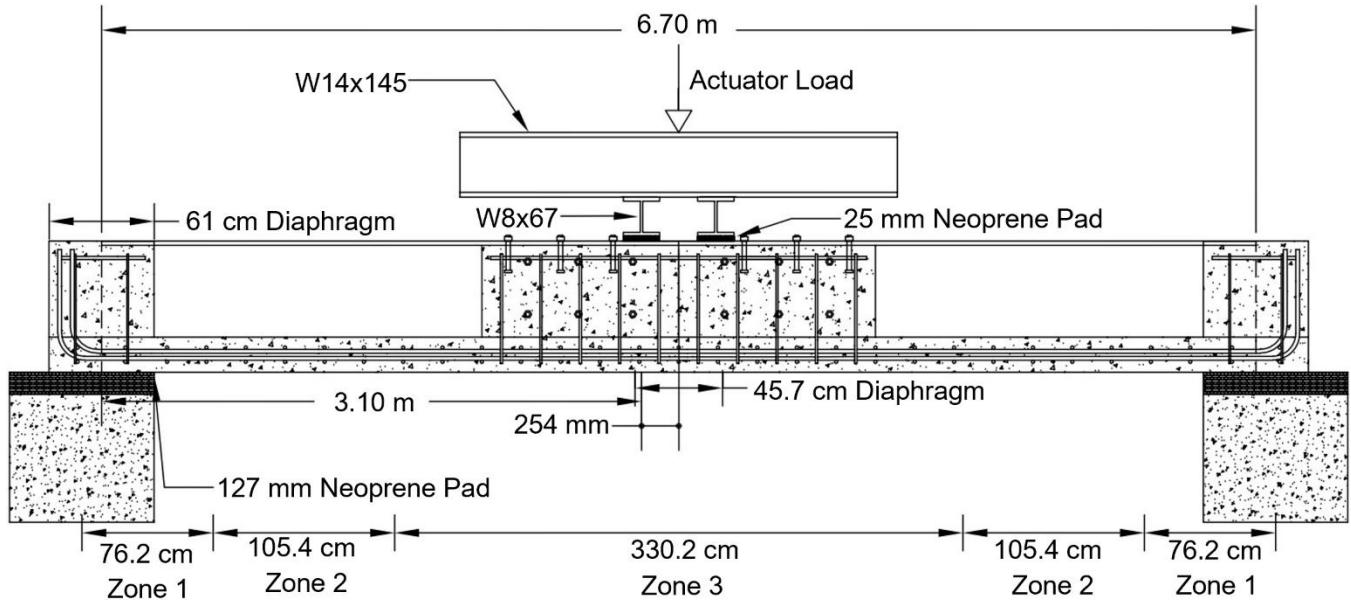
Figure 7: Four Point Bending Test Configuration

Material properties for the three girder zones denoted in Figure 7 are given in Table 1. Zone 2 was a typical CT girder section with the 19 mm thick foam-core web shown Figure 4b, whereas Zone 3 had a solid web where the foam core was replaced with six extra fiberglass plies. The solid web of Zone 3 was purposely extended approximately one girder depth beyond the end of the concrete infill region to promote good stress transfer over the full continuity joint length and avoid an abrupt transition of the FRP girder section at the start of the concrete infill. Zone 1 included both the foam-core and the six extra glass plies, which is typical at CT girder simple supports to ensure that the web can carry concentrated reactions without crippling or excessive local deformation.

As shown in Figure 7 the test specimen was subjected to four-point bending with closely spaced load heads using a 2000 kN hydraulic actuator. The actuator applied the load to a W13x145 spreader beam, which transferred it to two transverse W8x67 load beams. Each W8x67 load beam spanned the width of the diaphragm and was continuously supported by a 25 mm thick neoprene bearing pad. The load beams were spaced at 508 mm to mimic locations of individual bearings on which each girder would rest in an actual bridge. The end diaphragms were supported on 127 mm thick neoprene bearing pads to allow free rotation.

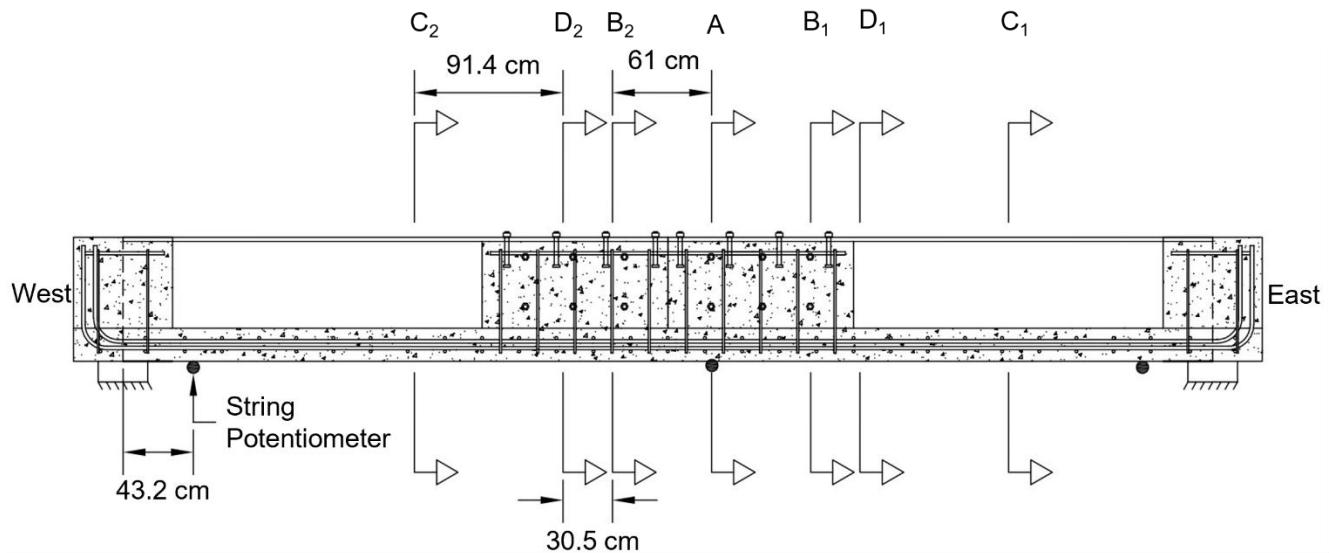
Figure 8: Layout of instrumented sections

During testing, longitudinal strain gauges and string potentiometers were used to monitor the specimen's behavior as shown in Figures 8 and 9. A pair of string potentiometers were located at mid-span and near each support of the specimen. The total applied load was recorded through the actuator's internal load cell. The mid-span string potentiometers recorded mid-span deflections and the ones near each end were intended to capture neoprene bearing pad compression.

As shown in Figures 8 and 9, multiple uniaxial strain gauges were installed at seven different cross-sections to track longitudinal flexural strains along the length and over the depth of the specimen. Section C allowed the assessment of strains over the depth of the FRP section outside the splice region. Sections B and D were instrumented to assess the transfer of stress from the FRP section to the reinforced concrete infill at different locations along the splice. Finally, section A was instrumented to explore the behavior of the midspan reinforced concrete section where no FRP is present. As shown in Figure 9, strain gauge instrumentation at sections B and D included 10 gauges on the deck longitudinal rebar, gauges on each compression rebar, and eight gauges on the FRP section. Sections C that were outside the continuity joint region did not include the gauges in the compression bars, and section A of course could not include the FRP girder gauges. The acronyms used for the gauges are BT for bottom deck tension bars, TT for deck top tension bars, BF for girder bottom flange, BW for girder bottom web gauges, TW for girder top web, CB for compression reinforcing bars, and CF for the compression flange (Figure 8). When reporting strain results in section 5, the notation employed for the gauges at each cross-section is defined as follows. The two letters indicate the gauge location within the cross-section (refer to Figure 9), while the number at the end corresponds to the longitudinal location, where section labels ending in “1” are located in the east part of the specimen and section labels ending in “2” are located in the west part of the specimen (refer to Figure 8).

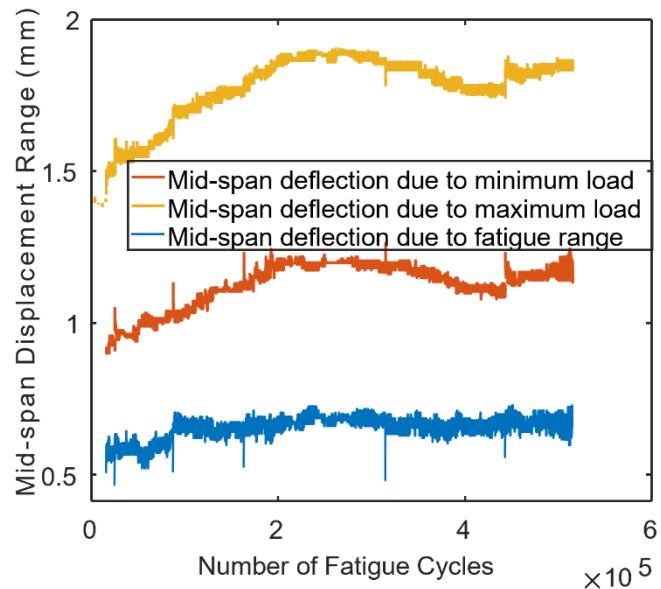
Figure 10: Mid-span displacement due to Fatigue range load

Figure 10 presents the mid-span girder displacement recorded by string potentiometers over the 514,863 fatigue cycles applied to the specimen. In addition to displacements due to minimum and maximum load limits, displacement caused by the fatigue load range is given to provide

insight into how the girder accumulates permanent deflection. Over the first 200,000 cycles, the overall displacement increases by about 0.5 mm. However, this could be due to accumulating permanent compression of the neoprene pads at the supports, and early deformations such as this are typical as a specimen and its supports settle during cyclic loading. After around 200,000 cycles, there were very small fluctuations in mid-span displacements, with deflections due to the fatigue range consistently oscillating between 0.63 mm and 0.70 mm.

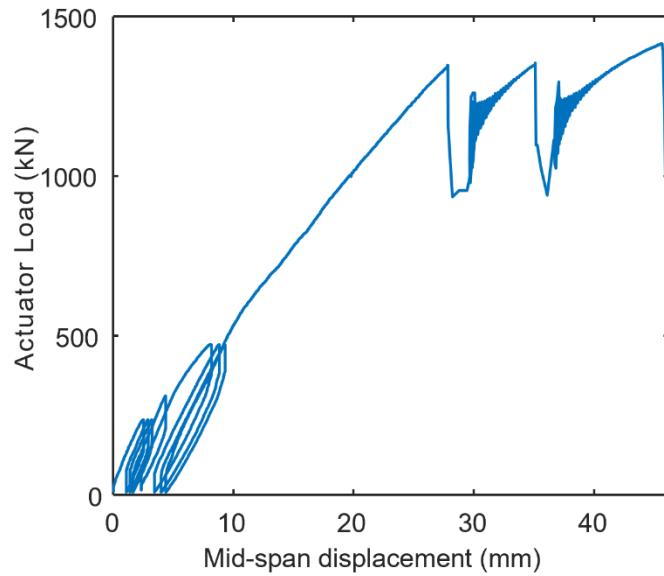
Figure 11: Load-Displacement Response of Specimen

Figure 11 shows the load-displacement response of the specimen for all cycles of post-fatigue loading. One cycle to 311 kN was inadvertently applied due to an operator error prior to loading the specimen to the full Service I load. It took approximately 30 seconds for each 50% Service I cycle, and 1 minute for each Service I cycle to be completed. After the last application of Service I load, the loading regime was switched from load to displacement control, but due to a second operator error the specimen was inadvertently loaded to failure at a rate of approximately 270 mm/minute. While this load rate is faster than desired, a subsequent review of the strain information in both the FRP and concrete indicated strain rates that were quasi-static for reinforced concrete (Zhang and Abedini 2023). Other research indicates that strain rates produced in the FRP were either at or only slightly above the limit of quasi-static (Ma et al. 2021; Cao et al. 2020; Jendli 2009) or below the quasi-static limit (Nejad et al. 2021). Further, the overall specimen stiffness (slope of the load-deflection curve in Figure 11) is essentially identical during both loading to Service I and while loading to failure. Based on this, dynamic and viscoelastic effects were insignificant despite the rapid rate of loading.

At the beginning of each cycle, and after reaching each peak of the cycle and beginning unloading, the string potentiometers did not record correctly, essentially giving a constant reading despite the initial change in load. Because of this, it was not possible to determine a true mid-span displacement by subtracting the average support displacement from the measured mid-span string pot reading, and Figure 11 therefore only reports the uncorrected mid-span string pot

reading. The apparent permanent deflection occurring after the first cycle of each load level is attributed to compression of the neoprene layer at the supports.

The first failure occurred due to buckling of the compression flange near the west end of the splice at a load of 1348 kN as indicated by the first peak in Figure 11. The load of 1348 kN, when combined with the specimen self-weight, produced a mid-span moment of 2181 kN-m, which is 50.7% greater than the 1447 kN-m AASHTO Strength I moment and 19.6% greater than the 1824 kN-m nominal moment capacity M_n of the midspan reinforced concrete section. This was followed by a similar buckling failure in the compression flange near the east end of the splice that was smaller but visible over the compression flange width at the second peak load of 1355 kN. Ultimately, at 1416 kN the original buckling failure in the west section of the specimen progressed to a complete fracture of the compression flange and webs (refer to Figures 12 and 13). A video of the specimen taken during testing confirmed this failure sequence.

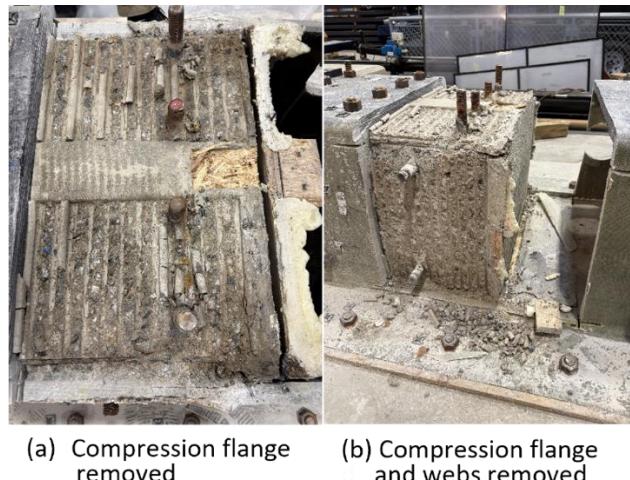
Figure 14: Failed specimen after removal of the compression flange and webs

A section of the specimen consisting of the compression flange and webs on the west side was removed to inspect internal damage. After removing only the compression flange, the web ridges and concrete splice remained bonded (refer to Figure 14). In Figure 14 it can also be seen that the concrete ridges in the compression flange/splice interface failed. While this damage could have been due to removal of the compression flange, the average shear stress at final failure computed per Eq. 1 with a moment at the specimen midspan of 2286 kN-m corresponding to the third failure load of 1416 kN is 6.39 MPa. This exceeds the strength of 4.12 MPa observed in the shear block tests using the Maine DOT deck concrete and A325 fasteners (Davids et al., 2022b) by 55.1%. If the moment at the bulkhead (end of the splice) of 1643 kN-m corresponding to a load of 1416 kN is used to calculate the average shear stress at failure, this gives a value of 4.59 MPa, which exceeds the assumed strength of 4.12 MPa by 11.4%. These results indicate that the concrete ridges at the flange interface could have failed during loading and not due removal of the compression flange. They also indicate that designing for the average interface shear stress computed using the moment at centerline pier may be overly conservative, and the moment at the bulkhead (end of splice) gives a better prediction of capacity. The FRP ridges remained intact in both the compression flange and webs, which is consistent with prior shear block tests (Davids et al. 2022b) and expected since the shear strength of the resin is greater than that of the concrete.

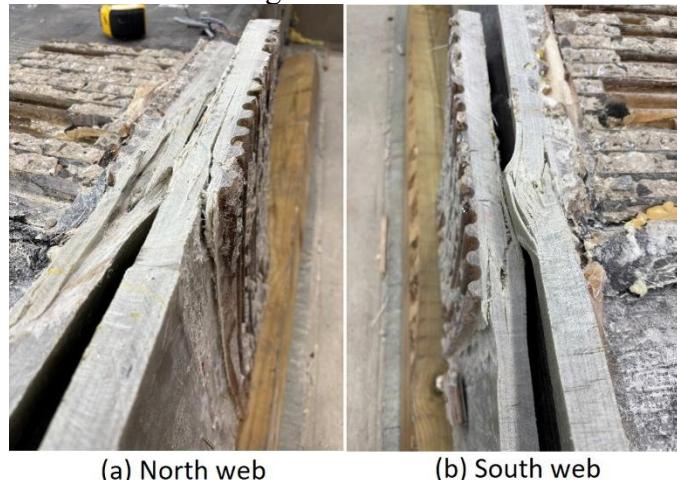
Figure 15: Delamination of the top of north and south web

An external inspection of the failed specimen showed that the compression flange buckling occurred near the bulkhead at 111.8 cm to the west of mid-span and at 112.4 cm to the east of mid-span. Removal and inspection of the compression flange in the west side showed that its bottom (interior) surface failed at 117.8 cm from mid-span, and buckling resulted in a diagonal failure plane through the thickness of the compression flange. Although no visible damage was found in the compression flange ridges or the web FRP ridges as mentioned, delamination of the FRP was observed near the top of both webs (refer to Figure 15). The damage in the webs took place near the end of the splice where the compression flange failure was observed (refer to Figure 12) and may have been caused by large web deformations and strains initiated by compression flange buckling.

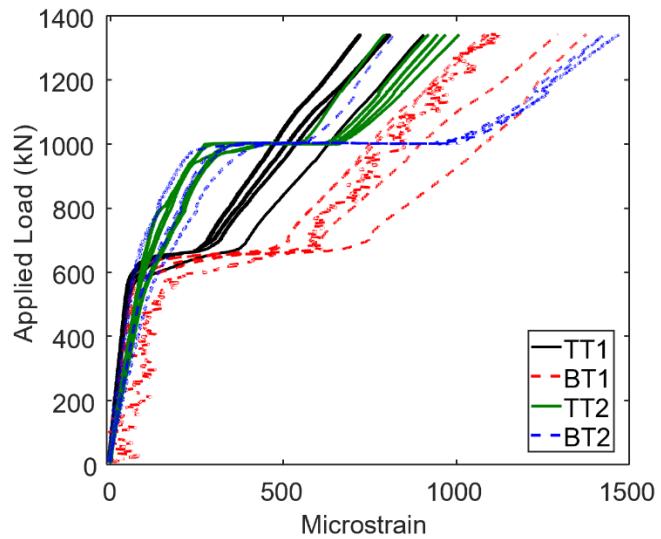
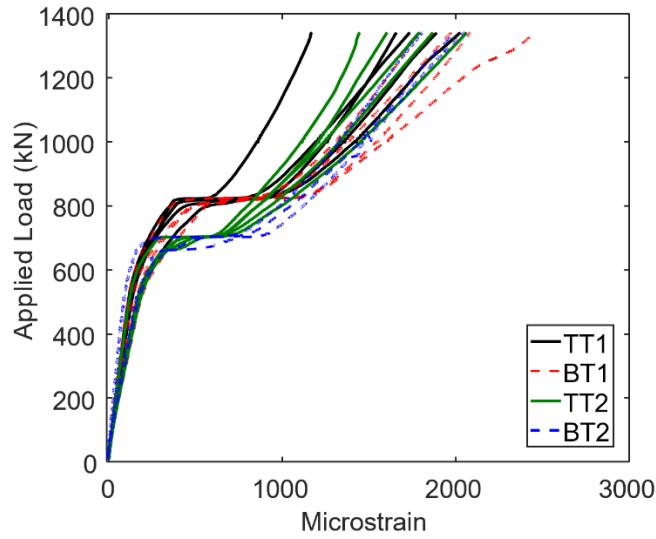
Consistent and repeatable strain readings throughout the specimen were observed for all Service I cycles. Figures 16 and 17 illustrate rapid increases in strain on the tension rebar at loads of 600 – 1000 kN for sections C and D, which can be attributed to deck cracking. The jumps in strain at different load levels suggest that the deck did not crack uniformly. For the C sections, the east part of the specimen near C₁ cracked first at approximately 625 kN, followed by the west part at 1000 kN. For the D sections, the west part near D₂ cracked first at around 650 kN, while the east part cracked at 800 kN. Cracking in the concrete deck at different load levels can be attributed to inherent inhomogeneity of the concrete and the variability in concrete tensile strength. Further, since discrete cracks did not occur exactly at instrumented cross-sections, their impact on measured strains is not symmetrical along the span.

Figure 16: Tension rebar gauge data until first failure for section C

Figure 17: Tension rebar gauge data until first failure for section D

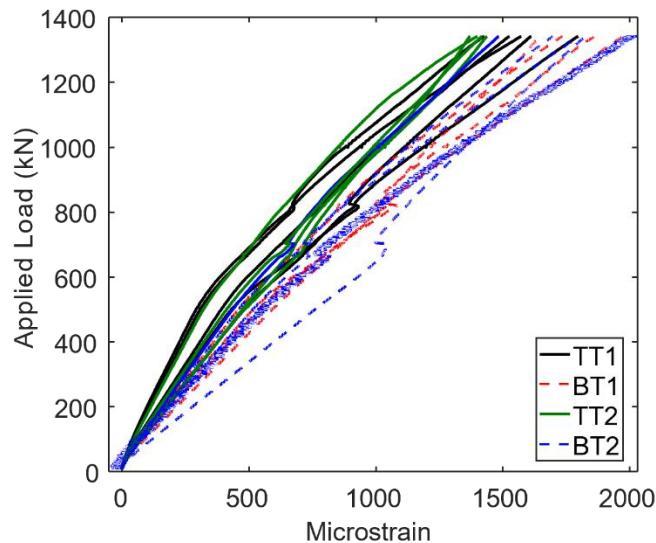
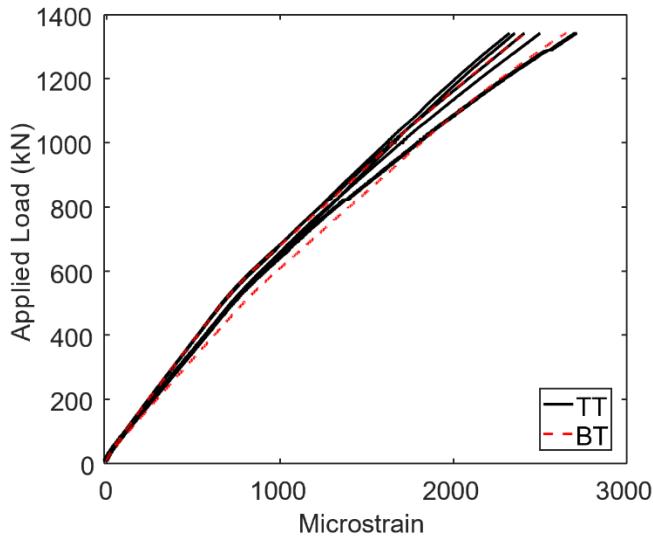
In contrast, the absence of such sudden strain increases in sections B and A (refer to Figures 18 and 19) suggests that cracking occurred earlier at lower loads. This agrees with the small amount of softening in the load-strain response in sections B and A that was observed during the first Service I cycle but not in subsequent cycles. The fact that strains in the tension reinforcing did not increase rapidly with small load increments after the nominal flexural capacity M_n for the reinforced concrete section A was reached at a load of 1117 kN (see Figure 19) suggests that the steel reinforcement did not yield. The maximum strain observed in the deck rebar of $2700 \mu\epsilon$ corresponds to a stress of 540 MPa if the steel remained linearly elastic, which is consistent with widely available Grade 550 rebar. These observations indicate that it is likely that a higher Grade 550 material was substituted for the specified Grade 413 rebar.

Figure 18: Tension rebar gauge data until first failure for section B

Figure 19: Tension rebar gauge data until first failure for section A

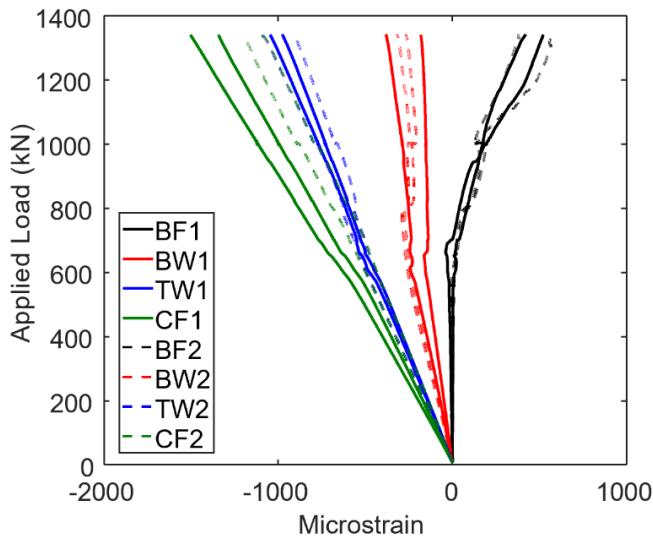
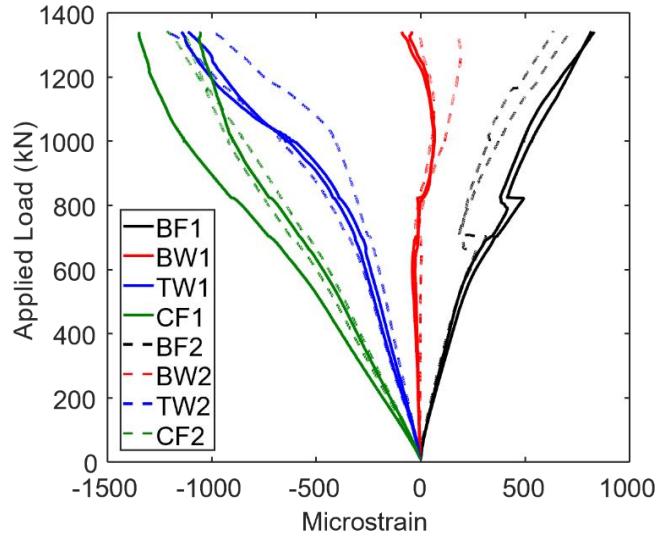
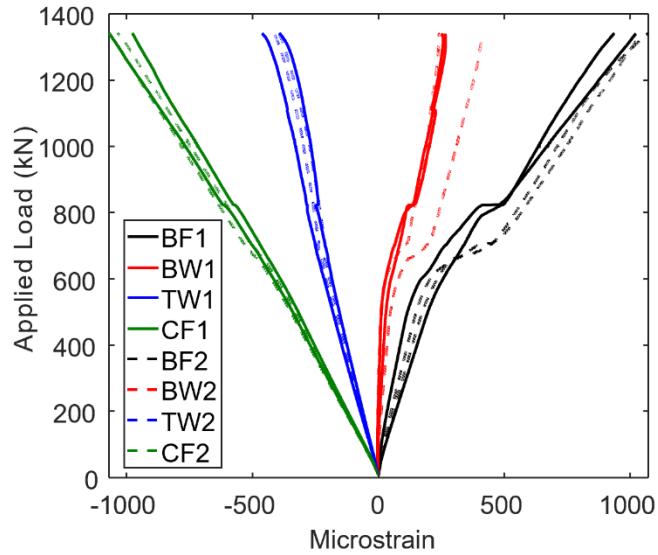
Figures 20-22 illustrate the FRP strains, and taken together reveal how the continuity joint and concrete infill influenced the strain distribution by taking part of the stresses that otherwise would have been carried by the compression flange. In the C sections, where only the girder and deck are present, the FRP displays the best example of a linear response (refer to Figure 20). As illustrated in Figure 21, strains are consistent at both D sections. At actuator loads of around 650 kN for the west side and 800 kN for the east side, both the rebar and the FRP strains reflect the influence of deck cracking in strain redistribution. In the case of the girder gauges, this is the most pronounced for the bottom flange, which shows sudden drops in tensile strain in the BF gauges at these loads. A similar shift can be seen in Figure 22 for the B sections where the strains at both the BW and BF locations appear to be affected by deck cracking. This suggests an increase of the influence of the concrete infill on the strain distributions closer to the midspan.

Figure 20: Girder gauge data until first failure for section C

Figure 21: Girder gauge data until first failure for section D

Figure 22: Girder gauge data until first failure for section B

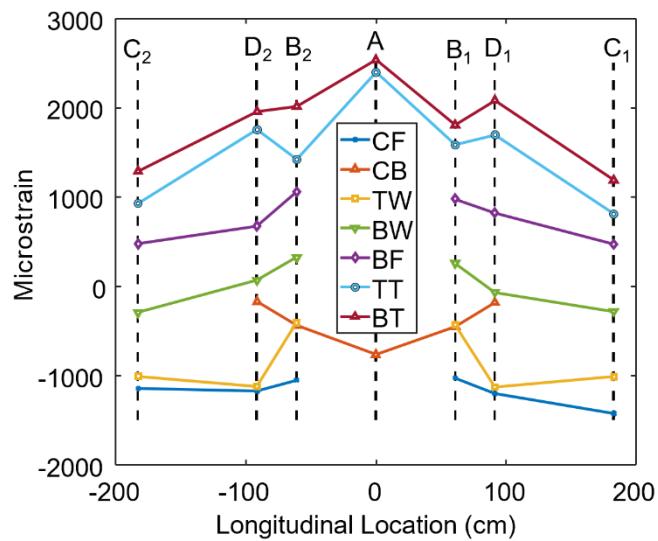
Figure 23: All gauge data until first failure for all sections throughout the beam

To further highlight influence of the concrete infill, Figure 23 shows the variation in strain along the span at the first failure load of 1348 kN at different locations in the specimen. These results imply that the neutral axis shifted up the section due to the presence of the concrete infill, and that the splice also altered the cross-sectional strain distribution as the infill concrete began to carry compressive stress. While the compression flange strain at first failure was similar in magnitude at sections C and D, the moment due to the actuator load at section D was 60% greater than that at section C. There is a more rapid decrease in the magnitude of the bottom flange FRP compressive strain between sections D and B at first failure even though the applied moment is larger at B. Consistent with this is an even larger decrease in compression strain at the TW gauges over the same region at the first failure load, and the BW gauges shift from carrying significant compressive strains at section C to very small compressive or tensile strains at sections D and B. In contrast, the strain in the compression reinforcing is modest at section D

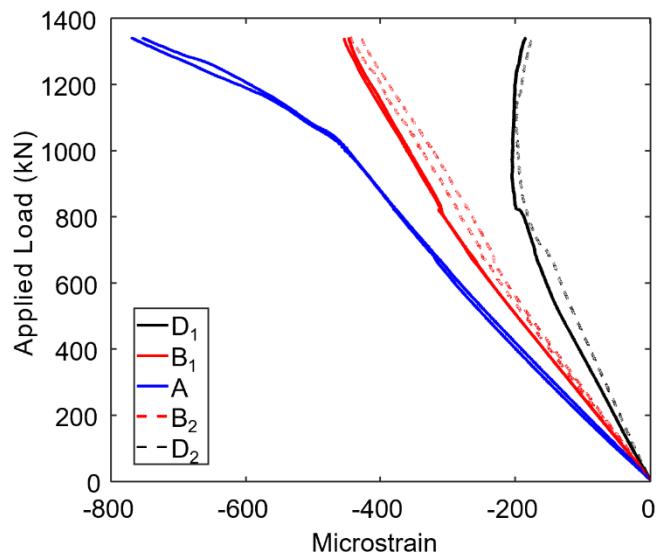
Figure 24: Compression rebar gauge data until first failure for all

(about $-200 \mu\epsilon$), but this increases in magnitude to about $-800 \mu\epsilon$ at section A (refer to Figure 24).

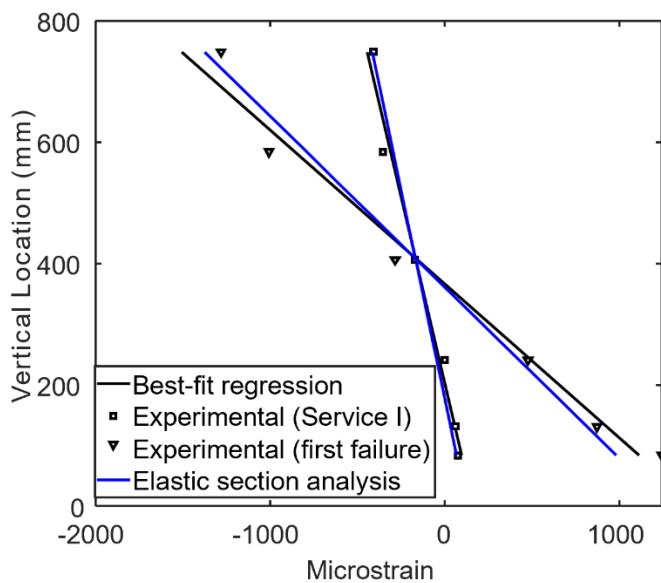
Figure 25: Section C strain profile for Service I (472 kN) and first failure (1348 kN) load levels

Figure 25 shows the variation in strain over the girder depth at sections C obtained using transformed section analysis along with experimentally measured strains. Best-fit lines were generated using average strain measurements from all gauges at the same vertical position. The results from both sections C_1 and C_2 were averaged to determine the strain profile at the Service I load (472 kN) and at first failure (1348 kN). The experimental results, despite the small deviation of certain values, are consistent with the assumption of a plane section remaining plane for linear elastic materials. At 472 kN, the best-fit line based on the measured strains indicates that the neutral axis lies is 200 mm from the section bottom, and at 1348 kN, it is 366 mm from the bottom. Elastic section analysis predicts a neutral axis position at 172 mm and 361 mm for loads of 472 kN and 1348 kN, respectively, which agree reasonably well with the values inferred from the experiment and confirming full composite action between the girder and concrete deck. Even though some deck cracking must have occurred before Service I, it was neglected when calculating the strain profile at 472 kN, and the deck was again assumed to be completely cracked when calculating it for first failure load level.

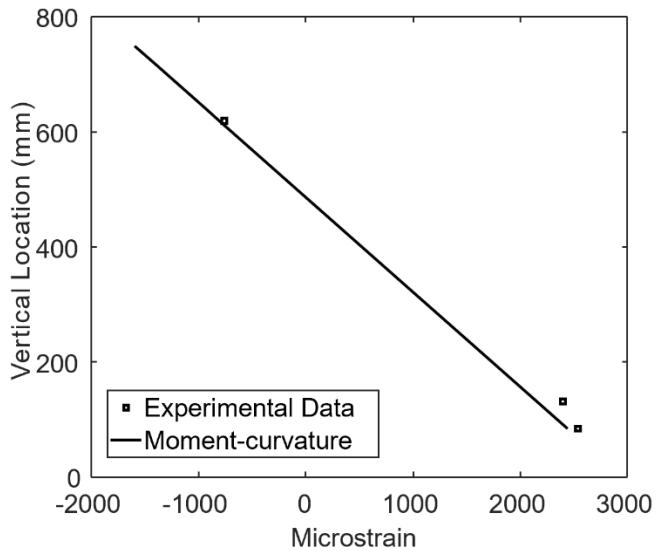
Figure 26: Section A extended strain profile and strain profile predicted from moment-curvature analysis at first failure

Assuming a plane section and using the three measured strains in section A at the first failure and linearly extrapolating gives a strain at the top fiber of $-1579 \mu\epsilon$. This indicates that the concrete did not reach its crushing strain during the test, although it was well beyond its linearly elastic limit given that peak strength typically occurs at a strain of about $-1800 \mu\epsilon$ for normal strength concrete. The moment-curvature analysis estimates a total strain of $-1599 \mu\epsilon$ at the top of the concrete section at midspan. Figure 26 summarizes the three measured strains and the strains predicted using moment-curvature analysis. The neutral axis based on the experimental data and moment-curvature analysis is 499 mm and 486 mm from the bottom of the section, respectively. Overall, the moment-curvature analysis shows good agreement with the experimental strain data at section A.

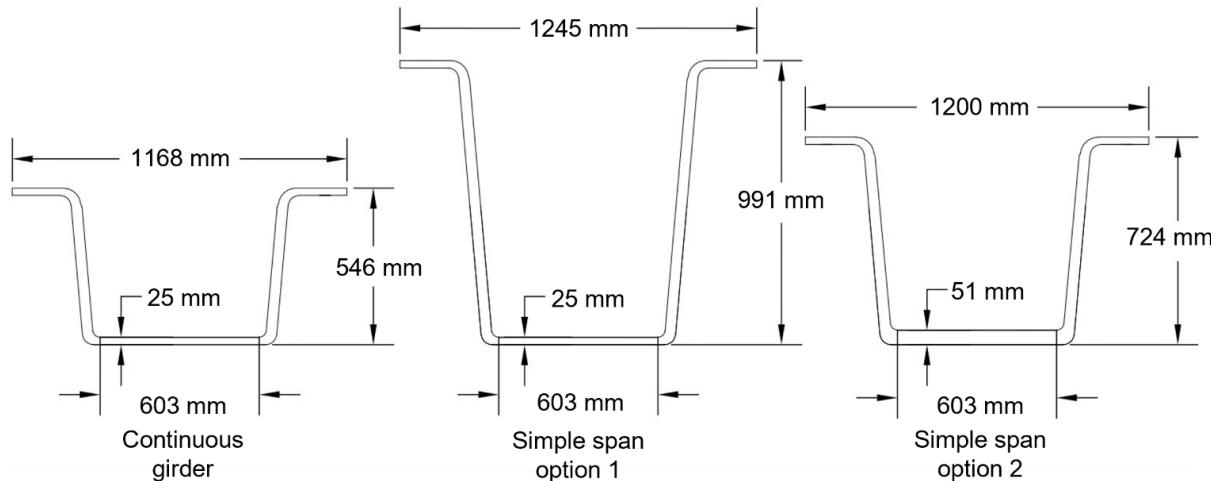
Figure 27: Girder cross-sections for three design conditions

Figure 27 summarizes the section dimensions for Options 1 and 2, and the original two-span section is also shown for visual comparison. A CT girder depth of 99.1 cm is required to limit deflection to 1.51 cm for Option 1. This gives an overall span to depth ratio of 12.8, which is 37% less than the 20.3 required for the two-span continuous bridge with the original cross-section. For Option 2, if the compression flange thickness is increased to the maximum feasible value of 51 mm the required CT girder depth becomes 72.4 cm to meet deflection requirements. This configuration results in an overall span to depth ratio of 16.4, which is 19% less than that of the two-span continuous bridge. Option 2 also requires a volume of unidirectional bottom flange carbon FRP of 0.4 m³ per girder, which is 250% greater than the 0.16 m³ per girder required for the 2-span continuous bridge and Option 1. Overall, these results illustrate clear gains in structural efficiency and material economy due to the live load continuity joint.
