Project 3.16: CT Bridge Girder Sections with Precast Decks and FRP Girder-Deck Shear Connectors

Final Report
April 2024

Principal Investigator: William Davids Ph.D., P.E.
Department of Civil and Environmental Engineering
University of Maine

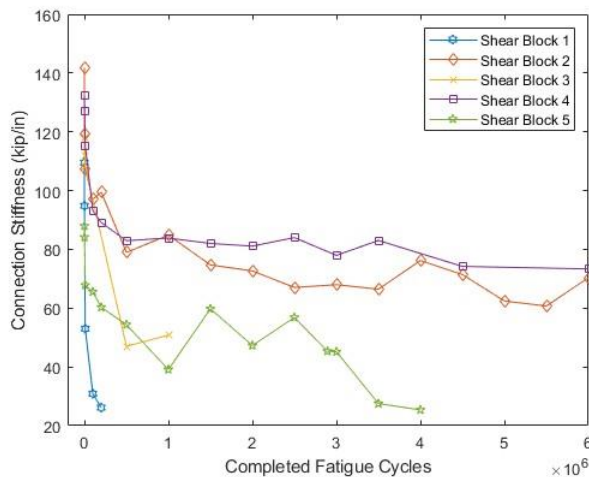
Figure 2-5: Stiffness Testing

The results of the periodic stiffness tests performed during fatigue testing are shown in Figure 2-5. To measure the connection stiffness, the displacement values used are the average slip values measured by the sensors against the starting displacements of the stiffness test. This is unlike the accumulated slip values used elsewhere where the slip is relative to the initial displacements of fatigue cycle 1. A linear-least squares fit of the load-slip curve was used to determine the slope of the periodic stiffness test curves, and therefore the periodic stiffnesses.

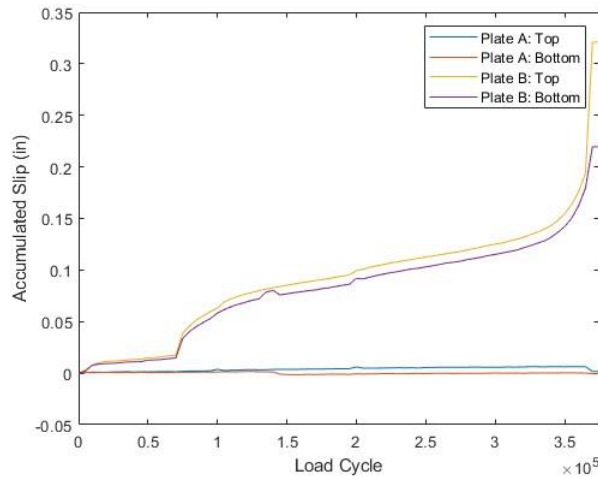
Figure 2-8: Shear Block 1 Accumulated Slip Vs Load

Figure 2-8 shows the accumulated slip of the shear connection at each fatigue cycle. Accumulated slip is the difference in initial slip between each load cycle and the first load cycle. Slip is the relative displacement of the shear-plate to the concrete block. Therefore, increasing accumulated slip values means the shear-plate is displacing relative to the concrete block because of each cycle, and is not an indication of intracycle slip increasing. Constant slip values indicate the connection is enduring the applied loads. Figure 2-8 shows the failed shear-plate's accumulated slip increasing throughout testing with rapid increases around 75,000 and 350,000

The rapid increases of accumulated slip in Figure 2-8 suggest damage occurring, as opposed to gradual increases indicating general wear in the connection. As it will be seen with future shear blocks, the first increase in slip to 0.01 in. is nearly double the maximum slip of the shear blocks that completed fatigue testing. This may have been caused by the FRP nut cracking since the nut restrains the plate from moving but does not carry the shear loads. Therefore, it could incur damage resulting in an increase in slip without the shear block completely failing. Furthermore, it likely is not a result of the concrete ridges shearing, as they are better explained by the second exponential increase in slip. Assuming the shear-plate was no longer restrained as intended, the ridges between the shear-plate and concrete had opportunity for partial contact. This may have deteriorated the ridges, sequentially shearing them off faster as less were available to carry the fatigue loads.

A probable root cause for the premature failure is a missing cross brace between the shear-plates of shear block 1. The cross brace is a steel threaded rod that is intended to prevent unintended eccentric loads from horizontally loading the shear-plates, causing the shear-plates to pry on the other shear connection elements. This prying could fatigue load these components in a way they were not designed for. Figure 2-9 shows a shear block with a cross brace and shear block 1 without its cross brace. Lastly, the low ridge quality of shear block 1, given in Appendix A, may have contributed to the premature failure by further reducing the contact of the ridges.

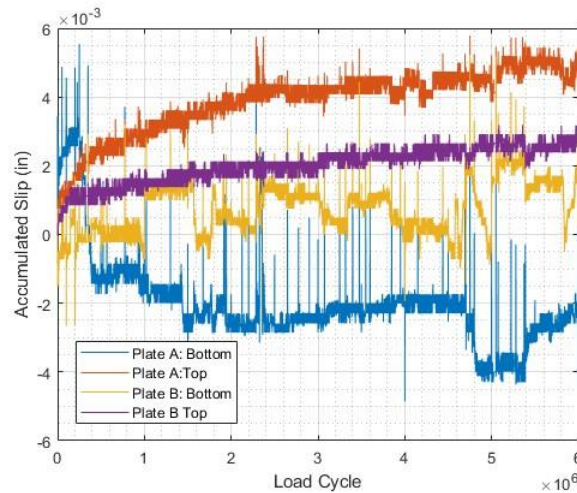
Figure 2-10: Shear block 2 Accumulated Slip Vs Load Cycle

Shear block 2 completed its six million fatigue cycles without failing. Figure shows the accumulated slip as a function of load cycle. The accumulated slip increasing indicates the connection displaced from its initial position at the start of fatigue testing. An initial increase during the first million cycles, followed by a gradual increase, as shown in Figure 2-10 are typical of previous shear block testing. However, the negative slips in the bottom of plate A are not expected behavior. A negative slip indicates the linear position sensor read smaller displacements over the course of testing.

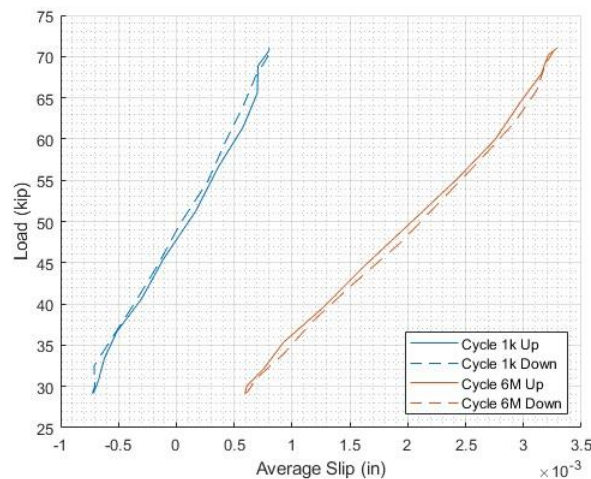
Figure 2-11: Shear Block 2 Average Slip Vs Load

Figure 2-11 presents the average slip from the four sensors recorded during the 1,000th and 6,000,000th load cycles, showing the effects of load and duration on the recorded slip. The horizontal shift from left to right from the curve at 1,000 cycles to 6,000,000 shows the accumulation of permanent slip during testing. A clockwise rotation in the later curve indicates a decrease in the connection's stiffness, leading to a larger slip at the same load. Lastly, it can be observed from the minimal difference between the loading and unloading branches that there is little hysteresis in the system in either load cycle. This implies that only a small amount of intracycle damage was accumulated.

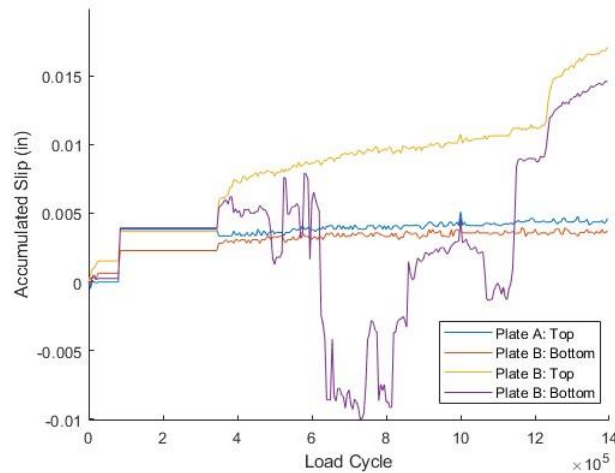
Figure 2-14: Shear Block 3 Accumulated Slip Vs Load Cycle

Figure 2-14 shows the accumulated slip as a function of load cycle for shear block 3. Increase in accumulated slip indicate displacement in the connection relative to its initial position. The flat lines in the data are a result of missing or corrupted data. During the missing data cycles, the accumulated slip appears to gradually increase as expected. After the missing data ends, the slips recorded in plate A remain relatively constant while plate B continues to increase. The erratic jumps in slip recorded at the bottom of plate B appear to be random, indicating the data from the bottom of plate B may be false readings.

Shear block 3 likely failed due to a load spike caused by a malfunction of the Instron controller. Despite the premature failure however, it is possible that the shear block would have failed prematurely during fatigue testing. Both the accumulated slip and stiffness of shear block 3 exceeded those of the specimens that completed 6 million fatigue cycles. Figure 2-114 shows the accumulated slip in shear-plate B near failure reached 0.015 in., three time that of shear block 2. Additionally, the stiffness of shear block 3 was already half that of shear blocks 2 and 4 at one million fatigue cycles as shown in Figure 2-5. Notably, a bend occurred in shear-plate A, which is unique to this shear block. This may be a result of combined bending and buckling in the plate. As plate B failed, the cross braced was pulled with it, applying a lateral bending force on plate A. Additionally, as the plate bent it was compressed as well, increasing the moment, and potentially buckling the plate as well.

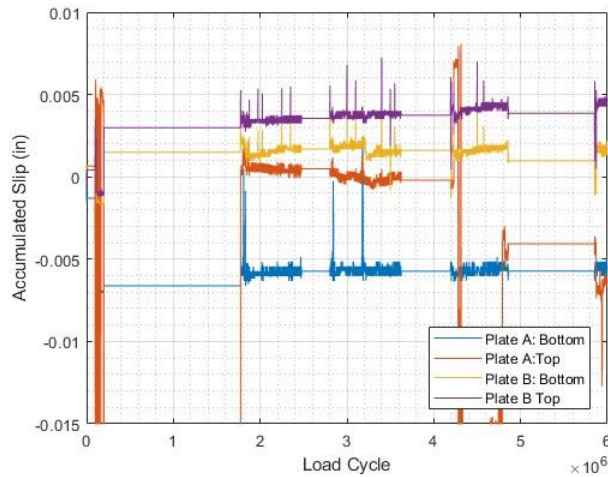
Figure 2-15: Shear Block 4 Slip Data

Shear block 4 completed six million fatigue cycles. Figure 2-15 shows the accumulated slips of the shear block as a function of completed cycles, where increases in accumulated slips indicate an increase in displacement between shear-plates and concrete. This shear block has several locations of corrupt data shown as flat lines. The sensor corresponding to the top of shear-plate A spikes in magnitude several times. Due to spikes in slip from the sensor at the top of plate A, the Y-axis of the plot has been cropped to better show the magnitudes of the remaining sensors' slip data.

The slip recorded by the sensor corresponding with plate A's top spiked in magnitude several times throughout fatigue testing. Since the other sensors did not record similar behavior, it is likely that unusable data was produced by the sensor. Therefore, this sensor was ignored when calculating the stiffness presented in Figure and the average slips presented in Figure 2-16. Much of the recorded data were corrupt, as seen by the horizontal lines in Figure 2-15. However, shear block 4 still shares the trends and magnitudes of accumulated and average slip with shear block 2 which also completed fatigue testing.

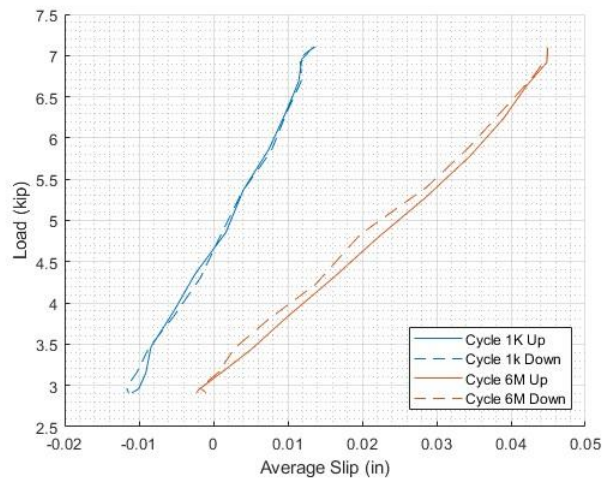
Figure 2-16: Shear Block 4 Average Slip Vs Load

Figure 2-16 shows the load-slip response of shear block 4 at 1,000 and 6,000,000 completed fatigue cycles. Since the sensor corresponding to plate A's top had noticeably larger magnitudes than the other sensors, and displayed erratic data trends, it was removed from the calculated average slip. The figure shows how the load-slip response of the shear block changed over the course of testing. This reveals accumulated slip through a horizontal shift in the curve, and a decrease in stiffness through a clockwise rotation.

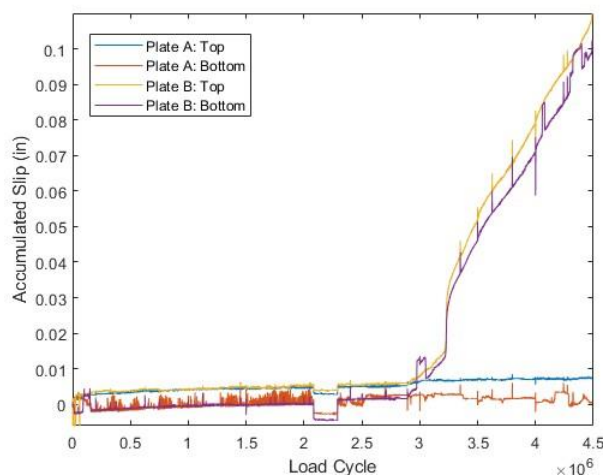
Figure 2-18: Shear Block 5 Accumulated Slip Vs Load Cycle

Shear block 5 completed 4.5 million cycles before the side of plate B unexpectedly failed as shown in Figure 2-17. Like shear blocks 1 and 3, the concrete ridges, bottom FRP nut, and Gbar shear connector had failed. Figure 2-18 shows the accumulated slips between the shear-plate and concrete block of the shear block over the test duration. These accumulated slips remained relatively constant for the first three million load cycles. After this, the slip in plate B began to increase rapidly, failing with 0.1 in. of accumulated slip. Figure 2-19 shows the average slip-load response of the shear block at 1,000 cycles and at 4.5 million complete cycles. Since the horizontal displacement between the curves is the difference in accumulated slip between the two cycles, the X-axis scale is relatively large for showing the slips within each load cycle. Additionally, the distance between these two curves is about 0.055 in. and not 0.1 in. since these curves average the slips of both sides of the shear block together.

Fatigue testing of shear block 5 was paused for four weeks during actuator maintenance after nearly 2.9 million fatigue cycles had been applied. During this time care was taken to minimize disturbance to the specimen, although it needed to be removed from the load frame to prevent damage. After completion of maintenance and restarting the test, block 5 failed around 1.7 million additional fatigue cycles later. When fatigue testing of shear block 5 resumed the accumulated slip in Figure 2-1 increased and the stiffness in Figure 2-5 decreased. This correlation suggests that the specimen's premature failure may have been impacted by the pause in testing, despite of the care implemented to minimize disturbance to the block during this pause. It is possible that the specimen could have been inappropriately moved or struck, causing damage. However, such damage is not likely considering no damage has occurred to date because of movement. Furthermore, an invasive procedure has previously been performed to remove shear-plates from shear blocks prior to testing in [7] without causing any issues. Therefore, it cannot be concluded that damage incurred during the pause caused a premature failure.

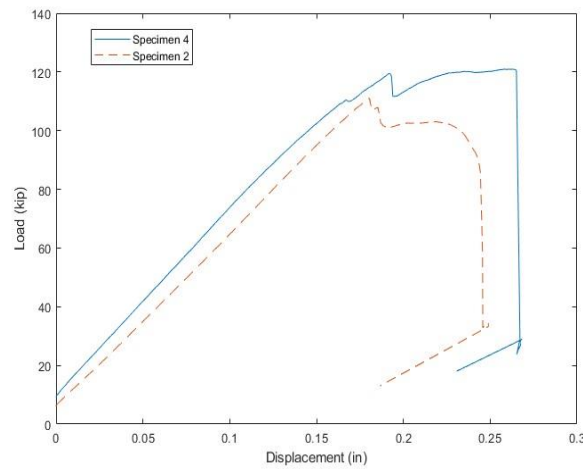
Figure 2-22: Strength Testing

Figure 2-22 shows the force displacement data recorded from the Instron during the strength testing of shear blocks 2 and 4. The curves are approximately linear until the first load drop, indicating elastic deformation in the shear blocks. After the peak, the load plateaus before rapidly dropping, and the failure was generally brittle.

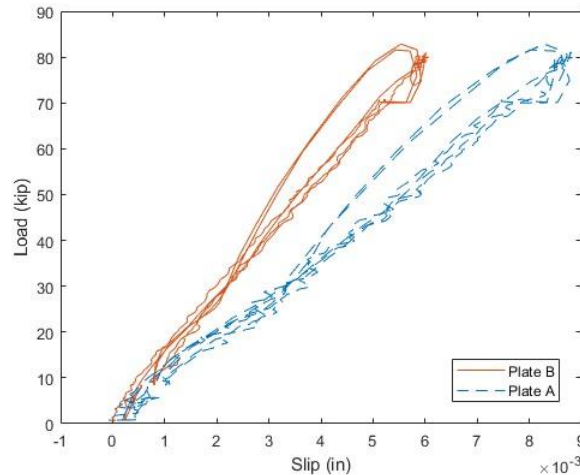
Figure 2-23: Shear Block 2 Pre-Failure Stiffness Testing

Figure 2-23 shows the resulting load-slip plot for shear block 2. The slip data are an average of the slip in each of the four DIC marker pairs. The corresponding load-slips curves behaved linearly while loading, but form “humps” while unloading. These may be a result of the actuator overshooting the intended loading, requiring operator intervention to manually unload the shear block each time. This is unexpected as shear block 2 was tested using the same programming that stiffness and strength tested shear block 4 already. Lastly, the figure shows that plate A has a lower stiffness than Plate B. This matches the general slip trends between Plate A and Plate B previously shown in Figure 2-10.

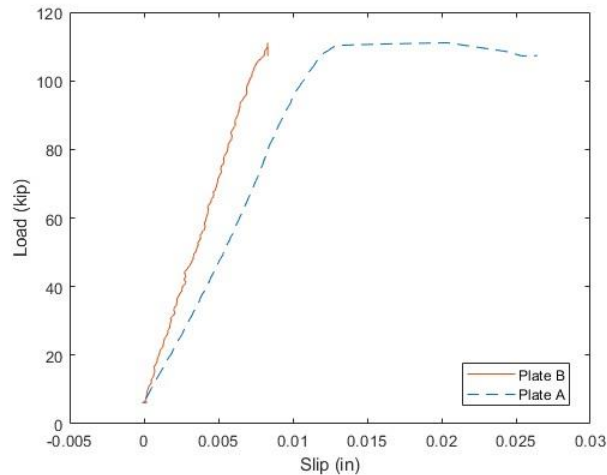
Figure 2-24: Shear Block 2 Failure

Plate A, the lower stiffness side, is also the side that ultimately failed during testing. Figure 2-24 shows the actuator load corresponding to the slips recorded between each shear-plate and the concrete block. The data in the plot has been cropped down to better show the slips leading up to failure, while Figure 2-2 shows the original data. In this figure Plate A appears to continue carrying diminishing amounts of load as permanent slip increases. However, this is not a ductile failure as previously discussed with Figure 2-22. Instead, Figure 2-2 shows that Plate B continued to carry load while Plate A failed. This is a result of the actuator measuring the gross load being resisted by shear block, and then that data being plotted against the slips in both plates irrespective of how much each plate contributes to resisting the load. Also, Plate B did not fail with Plate A because the actuator load head rotated away from Plate B.

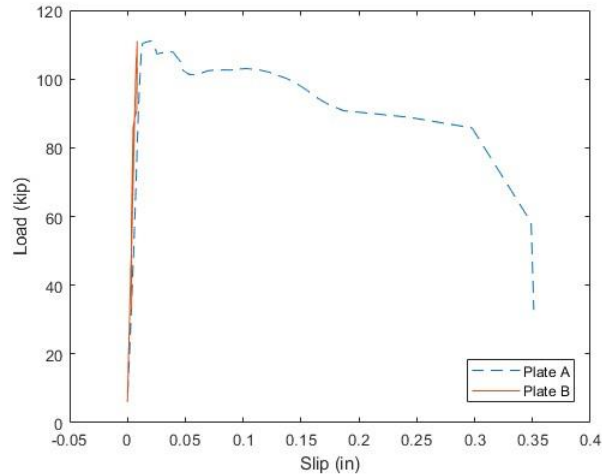
Figure 2-25: Shear Block 2 Complete Failure Curve

During the failure of shear block 2, there was a large and a small load peak, followed by a plateau preceding failure in Figure 2-2. To determine the corresponding failure sequence of the shear connection, the photos presented in Figures 2-26 and 2-27 were taken. Figure 2-26 shows the shear block post failure. Plate A was removed to examine the extent of the damage, revealing the concrete ridges had sheared off the specimen, and both FRP nuts had cracked. The G_{bar} however, had not failed in shear. Meanwhile, Figure 2-27 shows crack propagation through the bottom FRP nut as it split apart. These images correspond to the transition between the plateau in Figure 2-22, and the rapid load drop afterwards. From these images it is most likely that failure started with the concrete ridges at peak load. Then, the shear connectors began to bend as they carried more of the shear load. This caused the shear-plates to push against the FRP nuts, which then cracked under the loading. This allowed the shear-plate to then slide along the shear connector, unloading it.

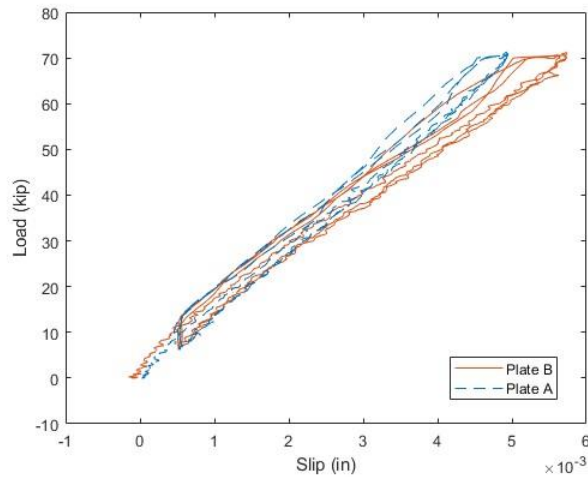
Figure 2-28: Shear Block 4 Pre-failure Stiffness Testing

Figure 2-28 shows the load-slip curves for each shear-plate on shear block 4. The slip is an average of the slips measured by Digital Image Correlation (DIC). The figure shows loading and unloading curves behaved approximately parallel and linearly. There is a small offset between the loading and unloading paths which may be a result of the neoprene bearing pad settling during a five second pause at the peak load and relaxing during a five second pause at the minimum load. Plate A was stiffer than Plate B, but the difference in stiffness between the two sides is much less than the difference in the two sides observed in shear block 2.

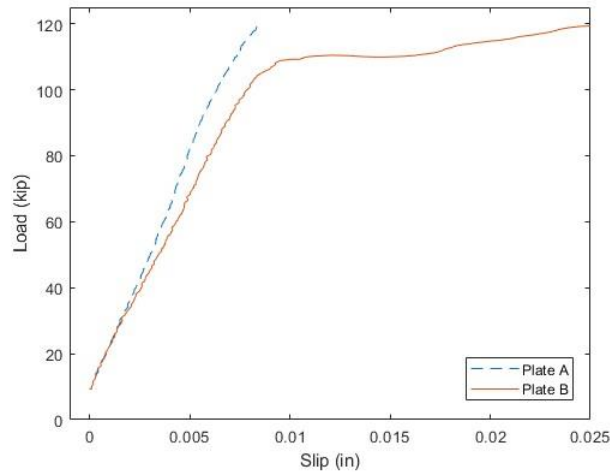
Figure 2-29: Shear Block 4 Failure

Figure 2-29 shows the load-slip relationship of shear block 4 during strength testing. This plot has also been cropped to better show the relative slips between the two shear-plates. However, the second load peak shown in Figure 2-2 is marginally higher than the first which Figure 2-29 is cropped to. Therefore, the slips relating to Plate B are cut off. The shear block was approximately linear to begin but gradually softened nearing the peak loads. Shear Plate B, the less stiff side, had an initial loss in stiffness while carrying load before failing once the shear block reached its second peak load. Shear block 4 sustained higher loads than shear block 2 before failing.

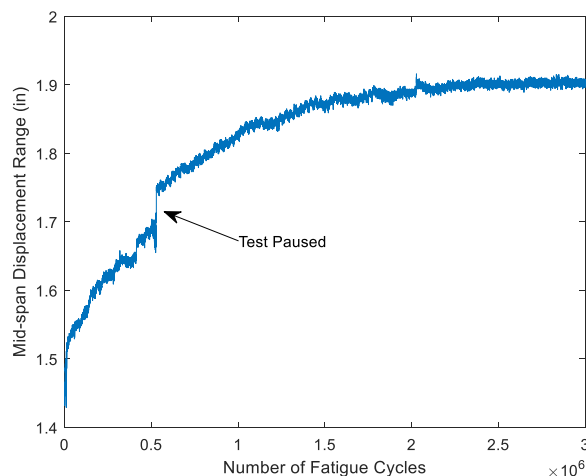
Figure 4-1: Calculated Displacement Range over Fatigue Testing

Figure 4-1 shows the mid-span girder displacement range (the difference between measured displacement at the top and bottom of the fatigue load range) with fatigue cycle. The minimum displacement range due to the 58.0 kip fatigue load range was 1.43 in. at the 100th load cycle, and this value increased to 1.91 in. over the course of cycling. As called out Figure 4-1, at about 600,000 cycles the test had to be stopped for several weeks due to a failure of the laboratory fire suppression system, and this was followed by a jump of about 0.080 in. of fatigue cycle displacement. Regardless, for the final 1,500,000 cycles the fatigue range displacement was very stable, ranging between 1.87 in. and 1.91 in. It is important to note that some of the total recorded displacement was likely the result of creep strains and shrinkage of the concrete deck, which were not independently monitored during the test. This is reflected by the change in actuator displacement corresponding to the minimum load of 6.0 kip, which increased by 2.17 in. over the course of the application of 3,000,000 load cycles, with 1.81 in. of this increase occurring during the first 1,500,000 cycles. Further, following completion of fatigue testing, girder mid-span deflection under no load was measured to be 1.57 in.

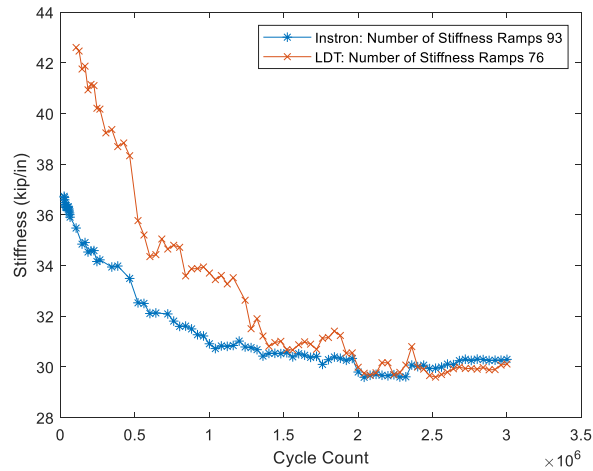
Figure 4-2: Stiffness Degradation over Fatigue Testing

Stiffness degradation during cycling was tracked by periodically performing pseudo-static load tests up to the maximum Fatigue I load of 64.0 kip. Actuator position was relied upon as the deflection measurement due the aforementioned issues with obtaining independent LDT data during testing. Specimen stiffness was computed for each test as the slope of the best-fit line to the measured load-deflection data over the range of 6.0 kip to 64.0 kip, and stiffnesses are plotted in Figure 4-2. These results show a stiffness loss of 17.5% after the application of 3,000,000 load cycles. Consistent with the results in Figure 4-1, however, the rate of stiffness degradation decreased with increasing fatigue cycles, and most of the stiffness loss occurred in the first 1,500,000 cycles. In line with these quantitative results, no visual signs of damage to the specimen were noted during testing.

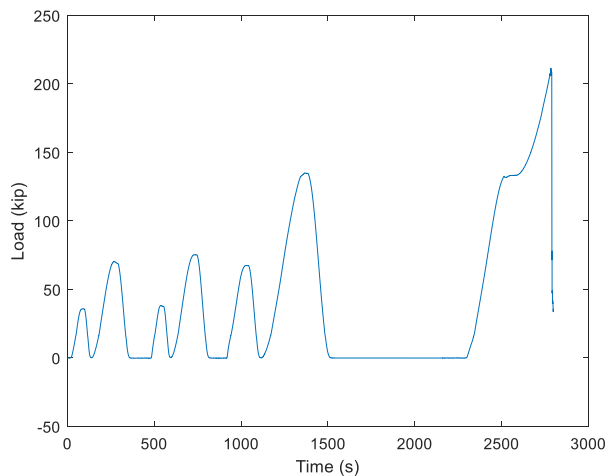
Figure 4-3: Strength Test Loading Sequence

UTC-4 was tested to failure on January 5, 2024, using a test protocol identical to that of UTC-3. Figure 4-3 shows load applied as a function of time. As can be seen, UTC-4 experienced catastrophic failure at a load of 212 kip after exhibiting a calculated stiffness of 29.9 kip/in during the load ramp immediately preceding the final ramp to failure. This is in contrast to the 313 kip load achieved by UTC-3 at a stiffness of 33.9 kip/in, drops of 32.3% and 11.8%, respectively. Figure 4-4 shows the load-displacement behavior of the girder over the course of testing, using displacements measured by both the external, midspan LDT and the actuator's internal LVDT, both corrected to account for compression of the elastomeric bearing pads. Deflections measured by both methods tend to agree well. Slip between the deck and girder were also measured with separate LVDTs, the data from which are presented in Figure 4-5. As can be seen, the measured slips were insignificant, indicating full composite action at all levels of load.

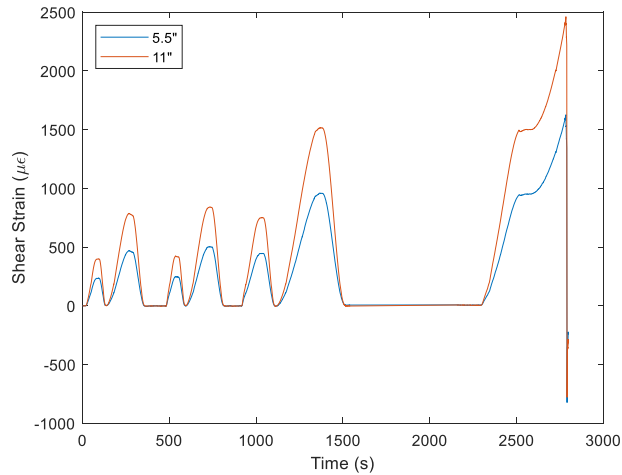
Figure 4-11: Shear Strains Measured 9 feet from the West Support

Figures 4-9 through 4-12 present shear strains measured over the course of strength testing at sections 3 feet and 9 feet from the east bearing and at sections 9 feet and 3 feet from the west bearing, respectively. As in the test of UTC-3, shear strains tended to increase proportionally to load and returned to zero upon unloading (except at failure). Generally, shear strains nearer to the bottom of the section tended to be smaller in magnitude than those higher up in the section as expected. This is true at all sections except the section 3 feet from the west support. In this case the measured strains seem to indicate the opposite effect. This may be due to a mislabeling of channels in the data acquisition hardware or a malfunction in one or more of the legs of the 5.5-inch-high strain rosette. As in the test of UTC-4, the shear strains measured further from the support tended to be larger in magnitude due to the difference in web facesheet thickness in the two locations.

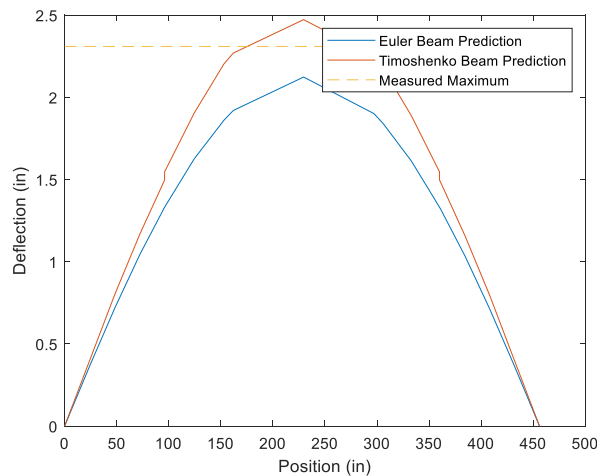
Figure 4-14: Comparison of Predicted and Measured Deflections under Fatigue-I Loading

Like with UTC-3, the deflection of UTC-4 was predicted under Fatigue-I, Service-I, Strength-I, and ultimate loading levels. These predictions were made by solving the boundary value problem with a finite difference solution technique under Euler-Bernoulli and Timoshenko beam theory assumptions. The results of these analyses are compared with measured deflection at corresponding load levels in Figures 4-14 through 4-17. As can be seen, the analyses that used Euler-Bernoulli assumptions tended to consistently underpredict midspan deflection, whereas Timoshenko assumptions overpredicted deflections by a smaller amount. This suggests that, like UTC-3, shear deflections are significant and should be considered.

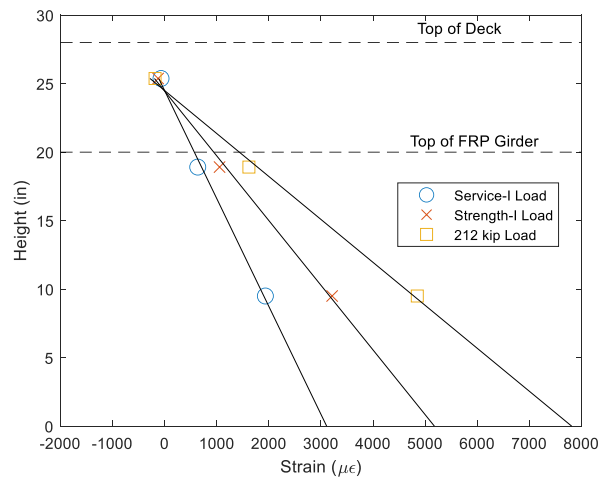
Figure 4-18: UTC-4 Longitudinal Strain Distribution

Measured longitudinal strains were plotted with height to determine the location of the neutral axis within the section. This can be seen in Figure 4-18 along with lines of best fit through these points. As can be seen, the neutral axis fell at approximately 24.3 inches from the bottom of the section at all levels of loading. This compares well with the neutral axes found when testing UTC-3. From the line of best fit for strains measured at a failure load of 212 kip, the strain at the bottom flange at midspan was projected to reach a magnitude of about $7750\mu\epsilon$. This compares well with the projected strain at 313 kip from UTC-3 as shown in Figure 3-22, showing a linear increase from one to the other. These observations combine to suggest that fatigue cycling did not significantly impact the elastic behavior of the girder.

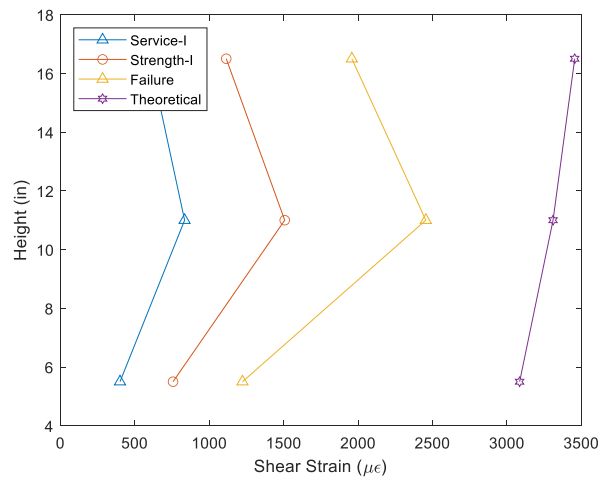
Figure 4-19: Shear Strain Distribution 3 feet from Support

As with longitudinal strains, shear strains were also plotted with height as seen in Figures 4-19 and 4-20 averaged for the sections 3 feet and 9 feet from the supports, respectively. The shapes of these distributions are similar to those of UTC-3, which is in contrast to the theoretically parabolic distribution expected. This is consistent with both girders' significant shear deflection as discussed above and provides further evidence of their similarity in elastic behavior.

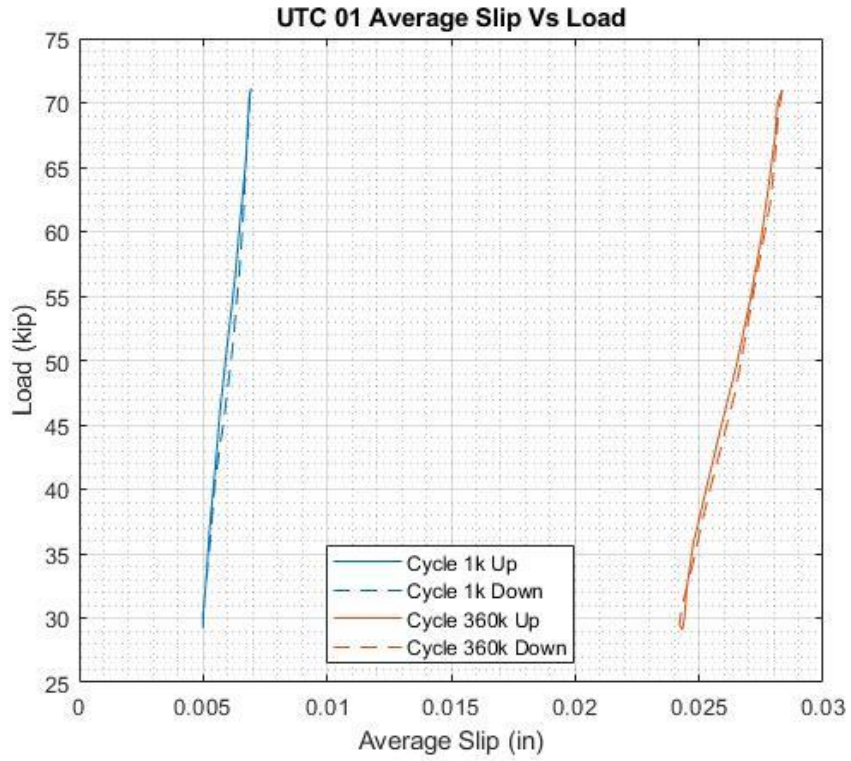
Figure Error! No text of specified style in document.-1: Shear Block 1 Average Slip Vs Load

Figure **Error! No text of specified style in document.-1** and Figure **Error! No text of specified style in document.-2** are the average accumulated slips of shear blocks 2 and 3 as a function of load at the load cycles shown in each of their keys. The horizontal distance between the curves is the average slip accumulated between the two cycles. The clockwise rotation from the curves left to right is the decreasing stiffness of the load cycle, meaning there is more intracycle slip later in testing. Lastly, a difference in loading and unloading cycles would indicate hysteresis from the loading, and likely the accumulation of damage.
